STRUCTURE SUMMARY

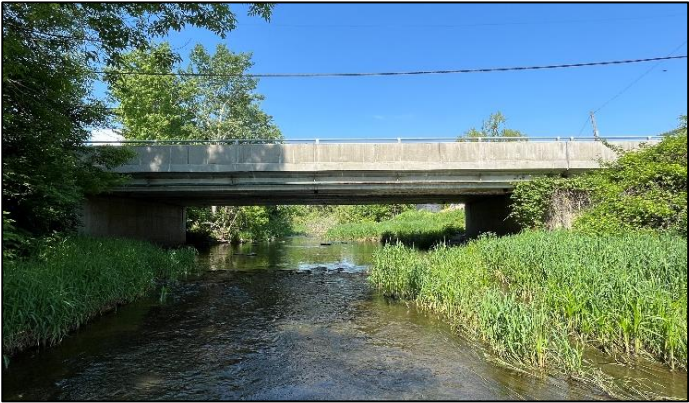
Year Built:	1964	AADT:	1200	Latitude:	45.03448346
Length:	20.5 (m)	No. of Lanes:	2	Longitude:	-75.39511146
Width:	9.5 (m)	Posted Speed:	50 km/h	Orientation:	North-South
No. of Spans/Cells:	1	% Trucks:	10	Roadway Width:	9 (m)
		Skew Angle:	0 (degrees)	Load Posting:	/ / (t)
Inspection Date:	1-Jun-2023	Inspector(s):	Grace Chang, EIT; Jacobs		
Type of Inspection:	Regular OSIM		Robert Banks; Jacobs		
Significant Findings:	Wearing surface exhibits severe pattern cracks and potholes throughout. Severe spalls with exposed corroded reinforcement and delaminations throughout girders along centreline of structure. Structure requires full replacement within 1 year. Recommended maintenance items include removal of vegetation overgrowth, cleaning of expansion joint seals and replacement of missing end cap on railing. No guide rails or hazard signs present and exposed end walls.

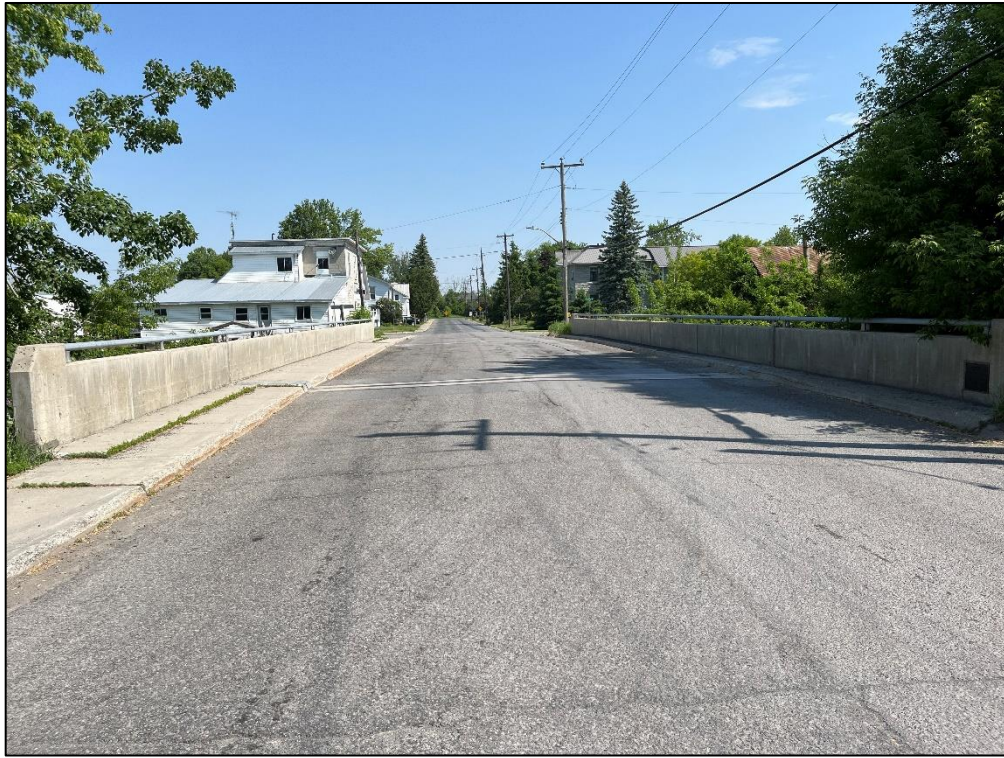
Photo 1 – Deck cross-section from south approach looking north.

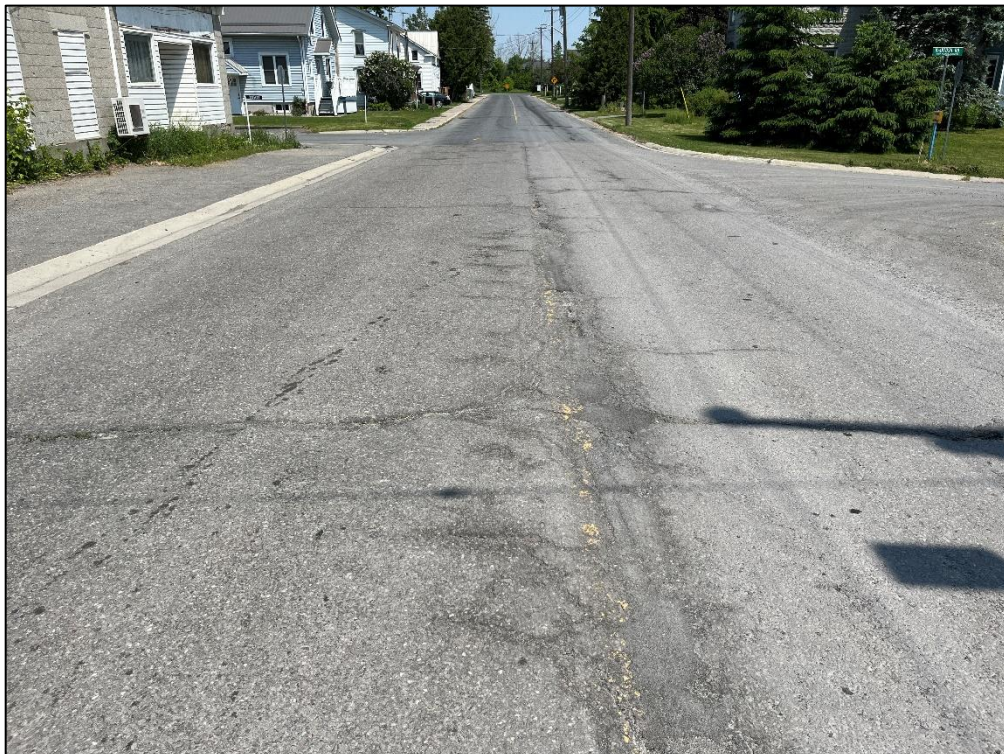
Photo 4 – Severe alligator cracking and loss of patching material in approach wearing surface resulting in severe potholes.

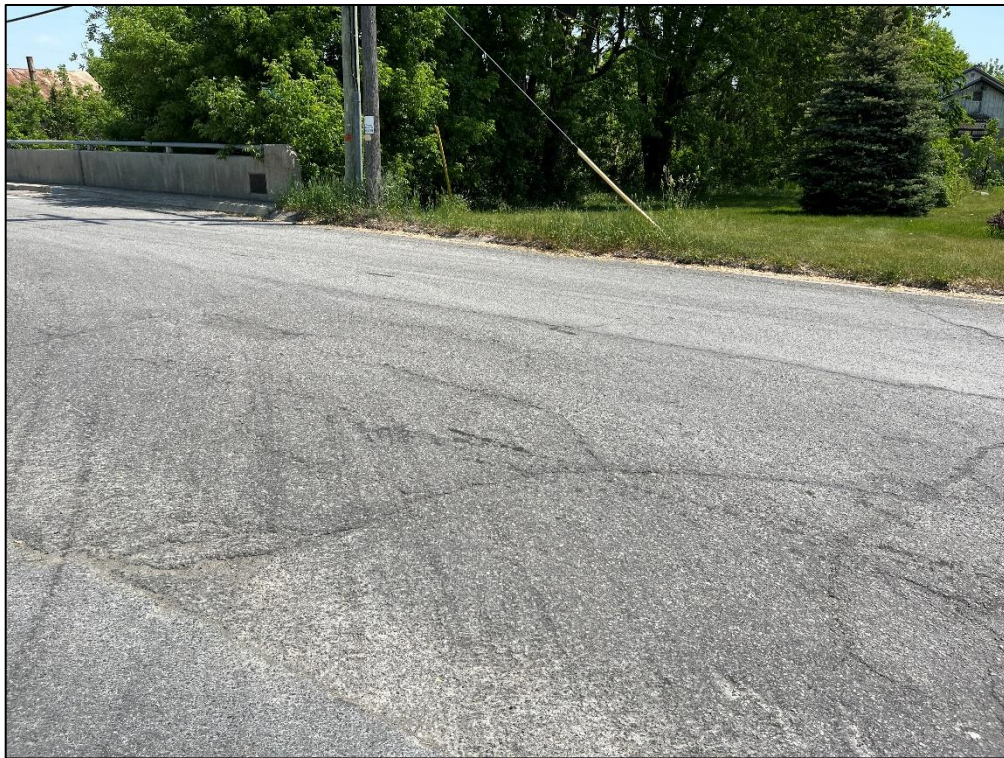
Photo 5 – Severe map cracking typical in approach wearing surface.

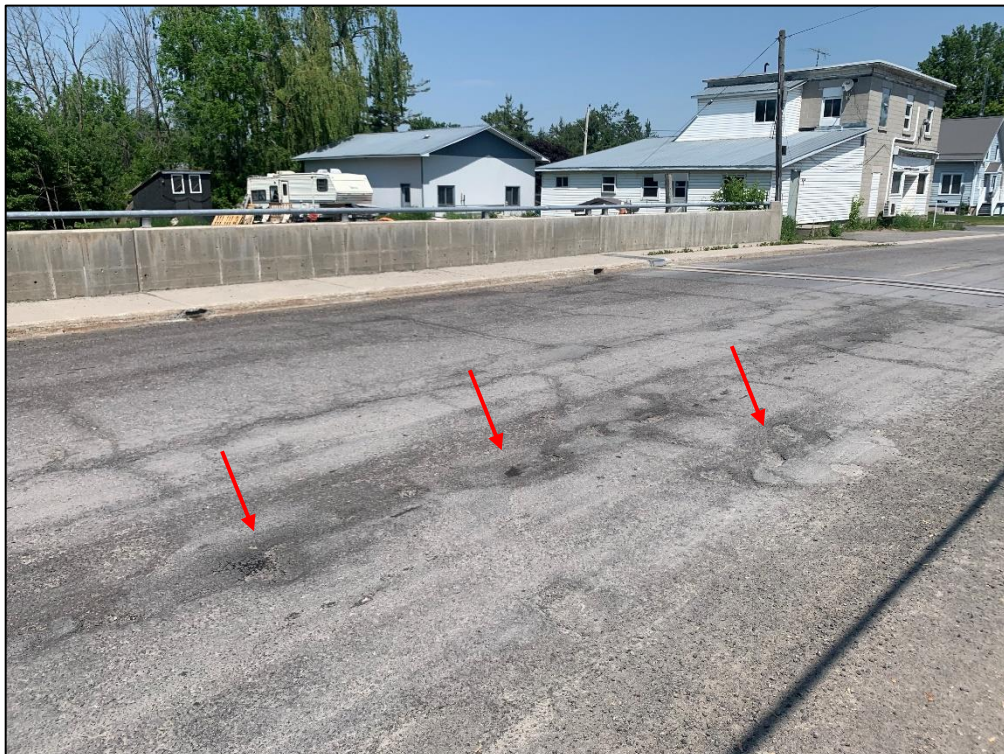
Photo 6 – Severe map cracking throughout deck wearing surface. Severe potholes in northbound lane.

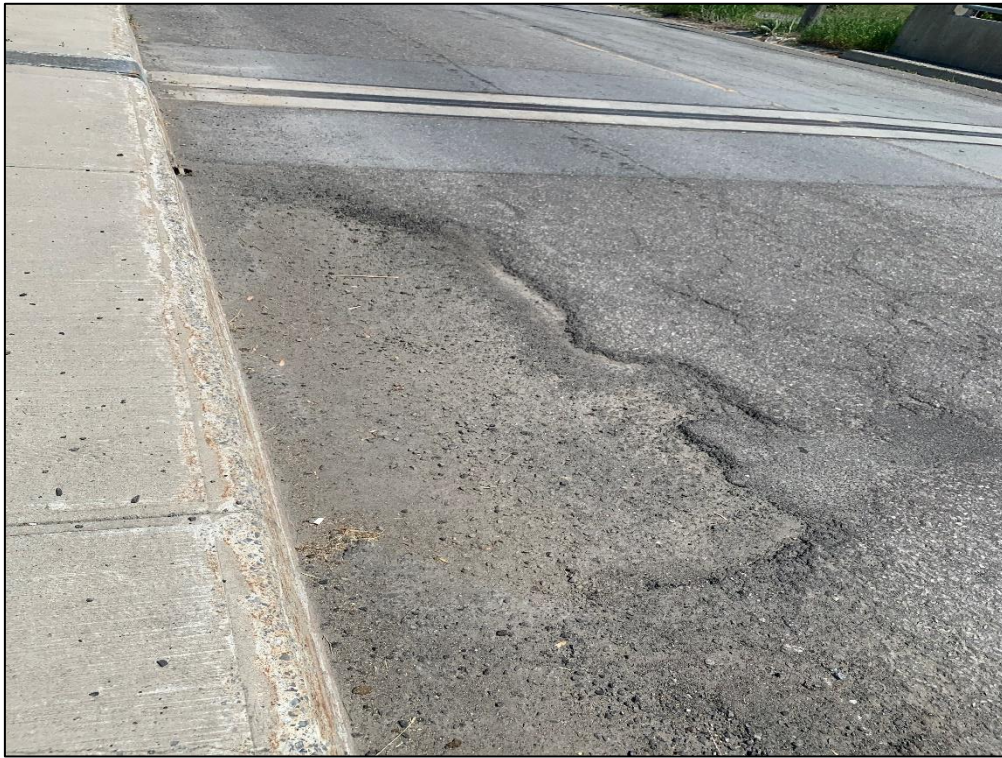
Photo 7 – Very severe raveling and loss of asphalt in northwest corner of deck wearing surface.

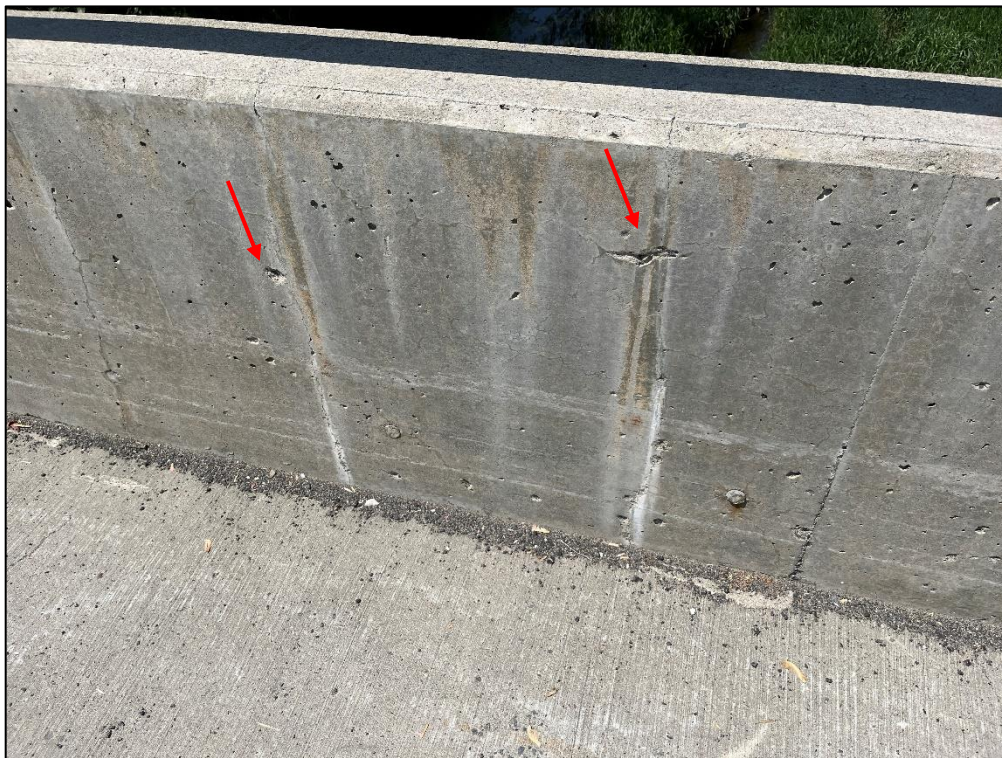
Photo 8 – Small localized spalls typical along east and west parapet wall interior.

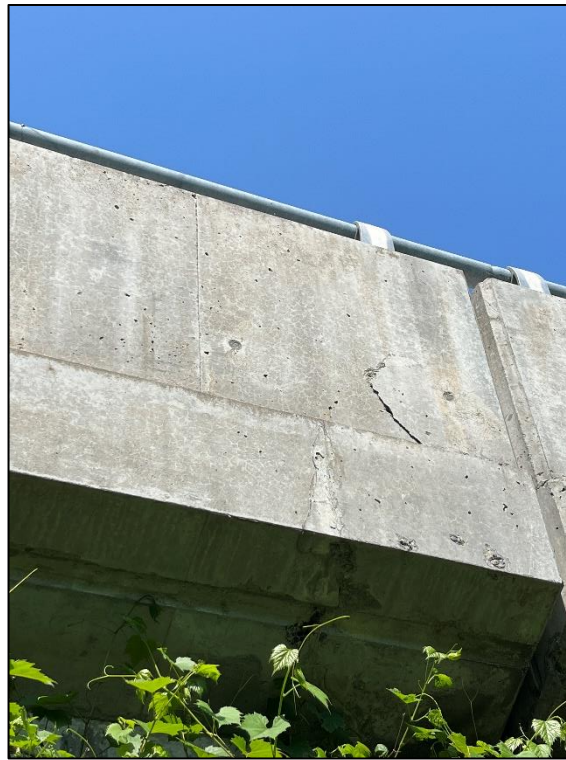
Photo 9 – Severe delamination along east parapet wall exterior.

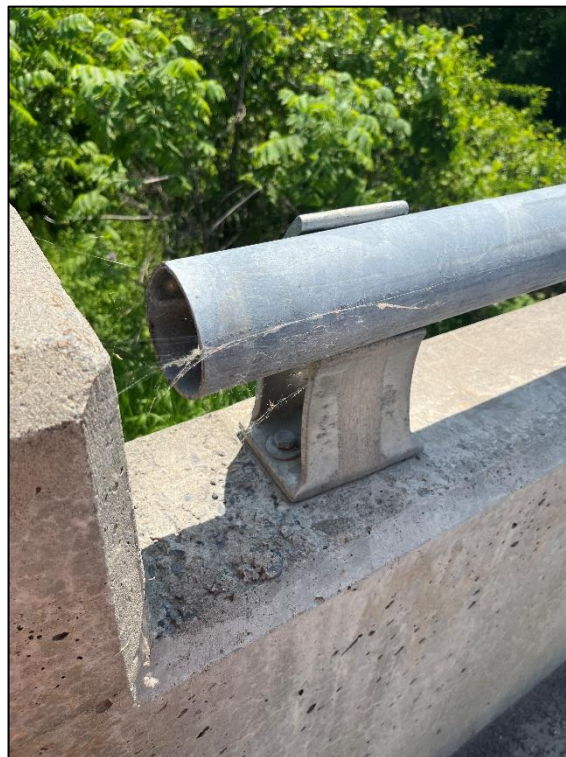
Photo 10 – Missing end cap at northeast end of hand railing.

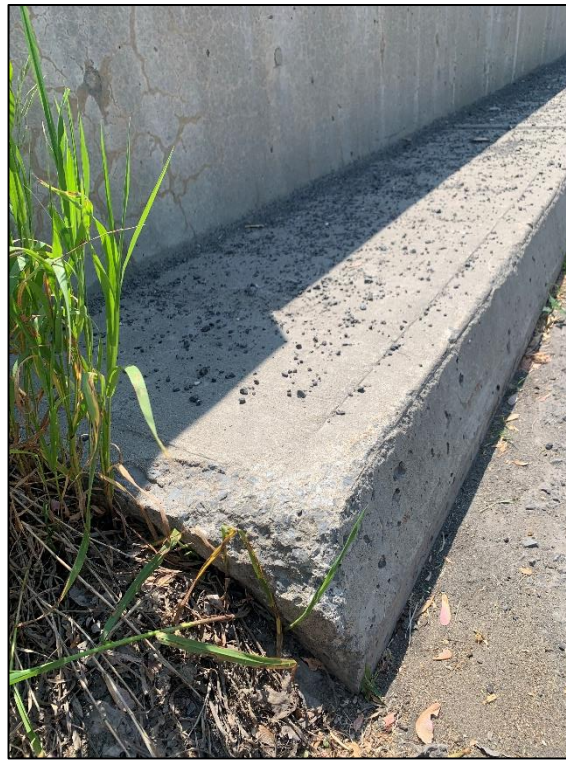
Photo 11 – Spall at north end of east curb.

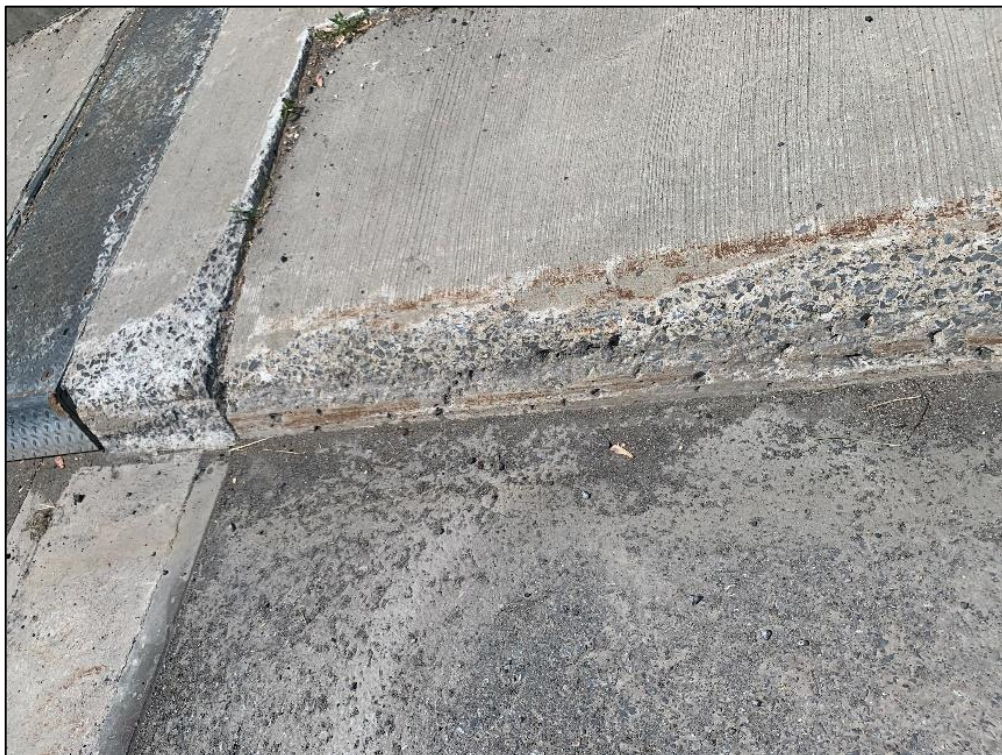
Photo 12 – Severe scaling and spall along west sidewalk.

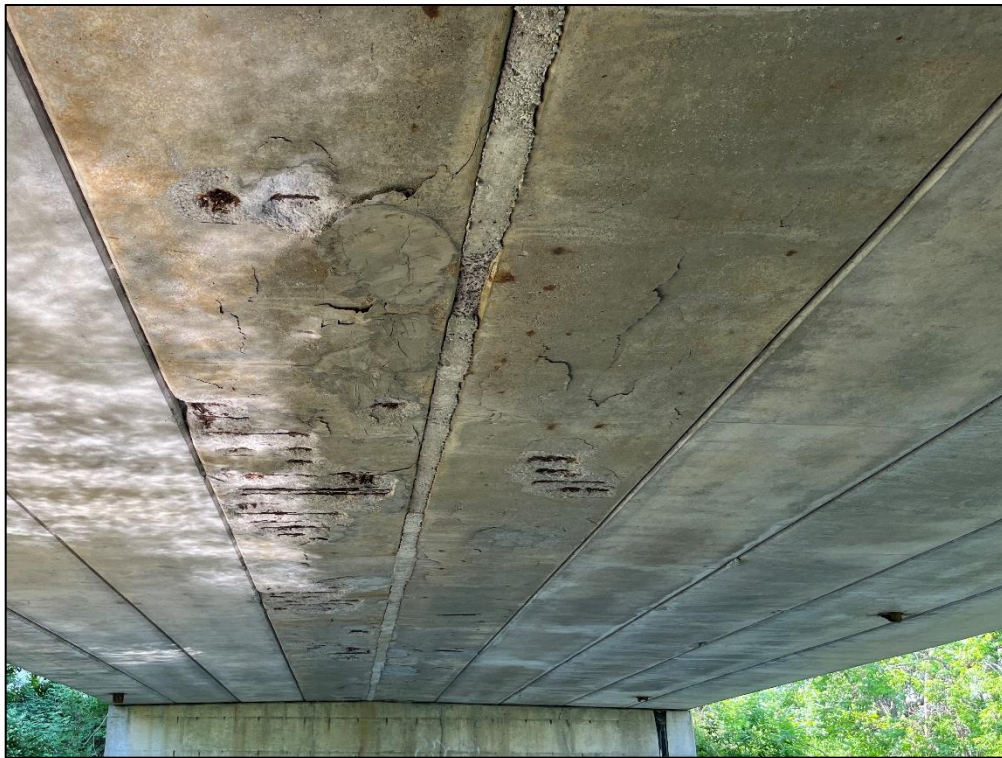
Photo 13 – Severe spalls with exposed corroded reinforcement and delaminated areas along entire length of two girders at centerline of structure.

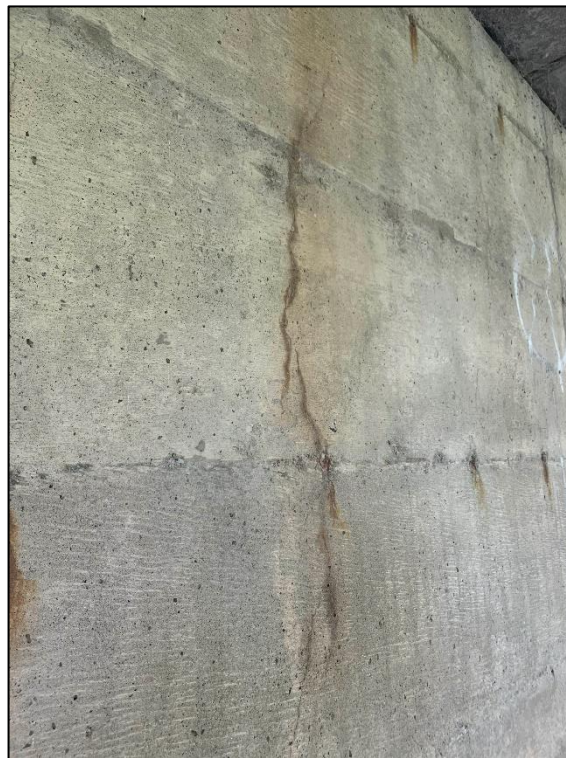
Photo 14 – Hairline to narrow vertical cracks with wet staining on south abutment wall.

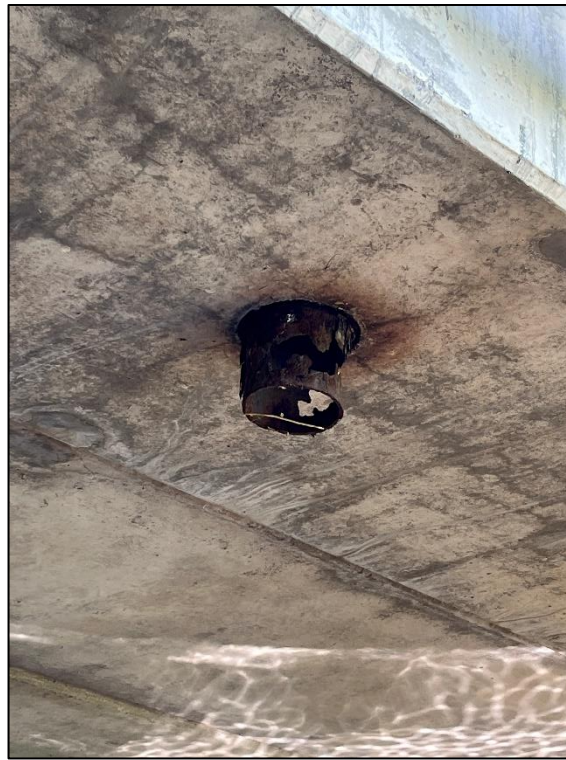
Photo 15 – Severe corrosion with perforations and section loss typical in deck drains.

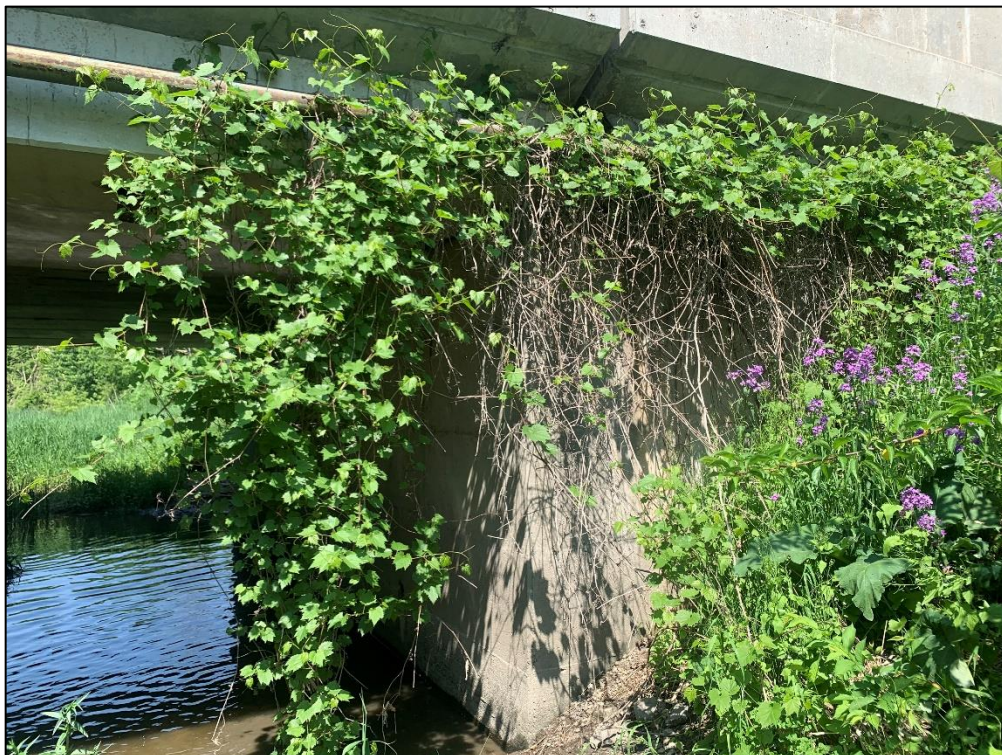
Photo 16 – Excess vegetation encroaching on wingwall and conduit at northeast quadrant.
