# Pre-renovation Designated Substances and Hazardous Materials Survey

Three Properties:

Amec Foster Wheeler Project No.: TY161003.7002

18 July 2016

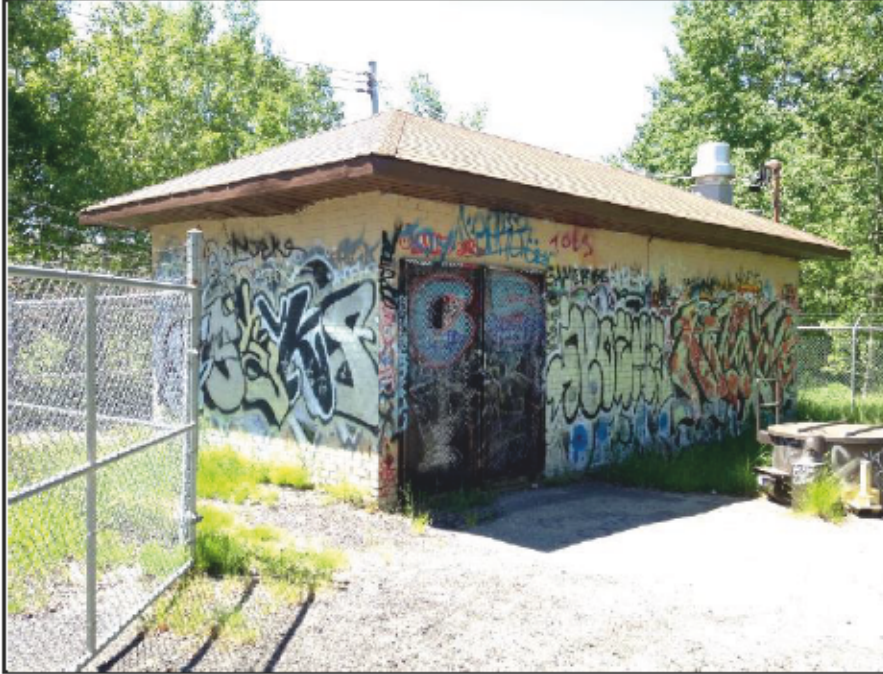
During the Site surveys, the majority of painted surfaces at two (2) of the three (3) Lift Stations were observed to be in fair condition. The exception was the interior white wall paint (poor condition) on the walls and the exterior graffiti surfaces (very poor condition) of the Bancroft Dr. Lift Station.

**Photo 1:**  
*Bancroft Drive  
Lift Station –  
Paint damaged  
by graffiti.*

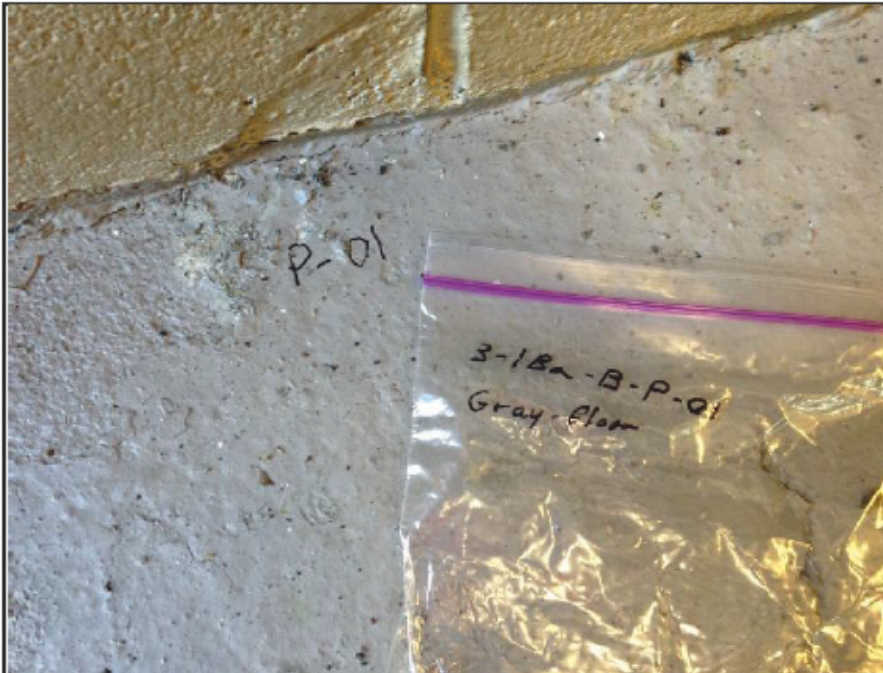
All of the samples collected were found to be below the 5,000 µg/g (0.5%) level, however, three (3) of the five (5) samples tested were found to be over 90 µg/g (0.009%), which will require lead handling procedures or special precautions. The interior and exterior painted surfaces are considered to be in very poor to fair condition.

**Photo 2:**  
*Bancroft Drive  
Lift Station  
Sample #  
2811Ba-B-P-  
01– Floor (grey)  
900 µg/g  
(0.090%) lead  
by dry weight –  
Condition – Fair*

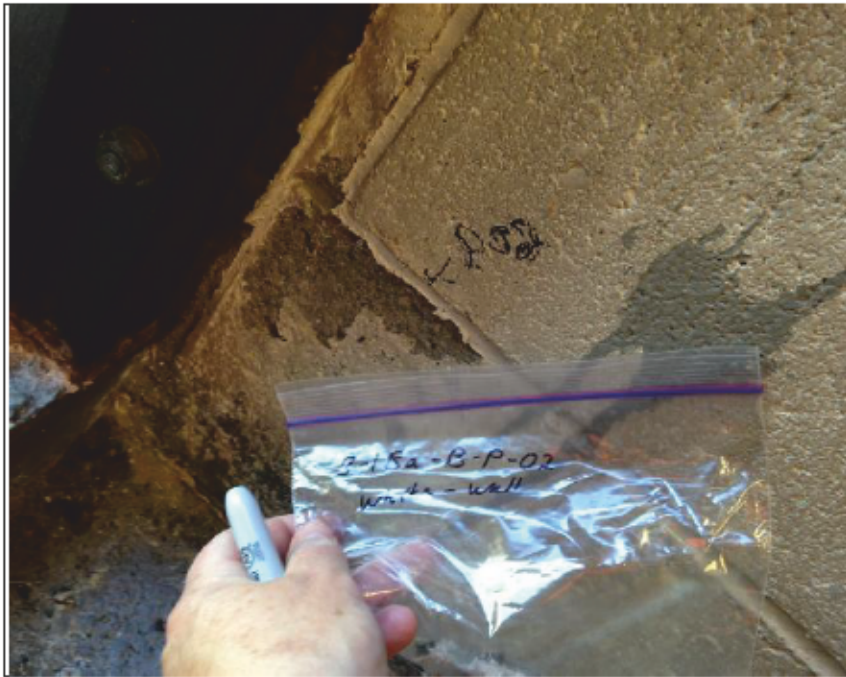
**Photo 3:**  
*Bancroft Drive  
Lift Station  
Sample #  
2811Ba-B-P-02  
– Walls and  
ceiling (white) -  
<math>68 \mu\text{g/g}</math>  
(0.0068%) lead  
by dry weight –  
Condition –  
Poor*

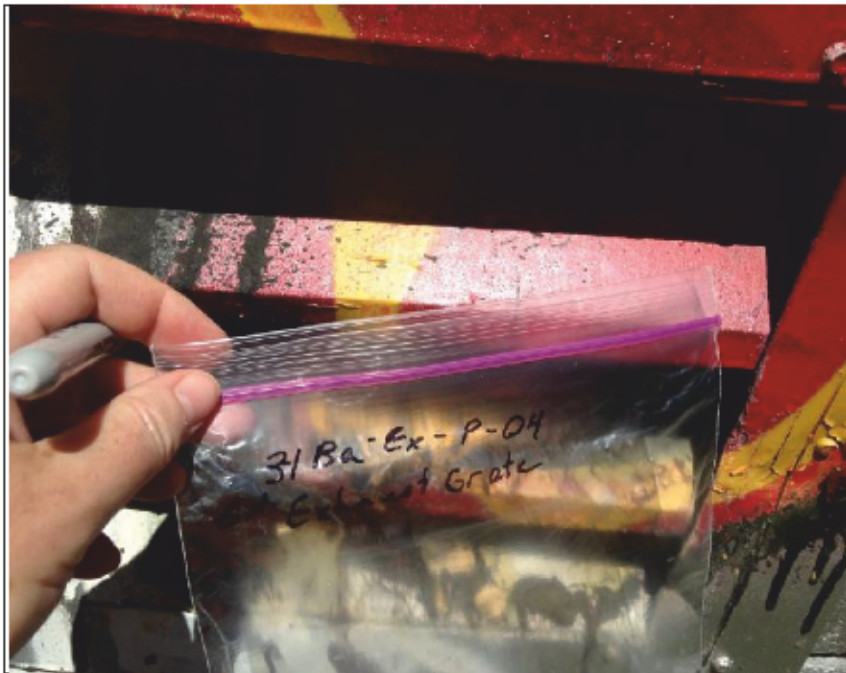
**Photo 4:**  
*Bancroft Drive  
Lift Station  
Sample #  
2811Ba-Ex-P-  
04 – Vent  
(graffiti mix) -  
<math>120 \mu\text{g/g}</math>  
(0.012%) lead  
by dry weight –  
Condition –  
Very Poor*

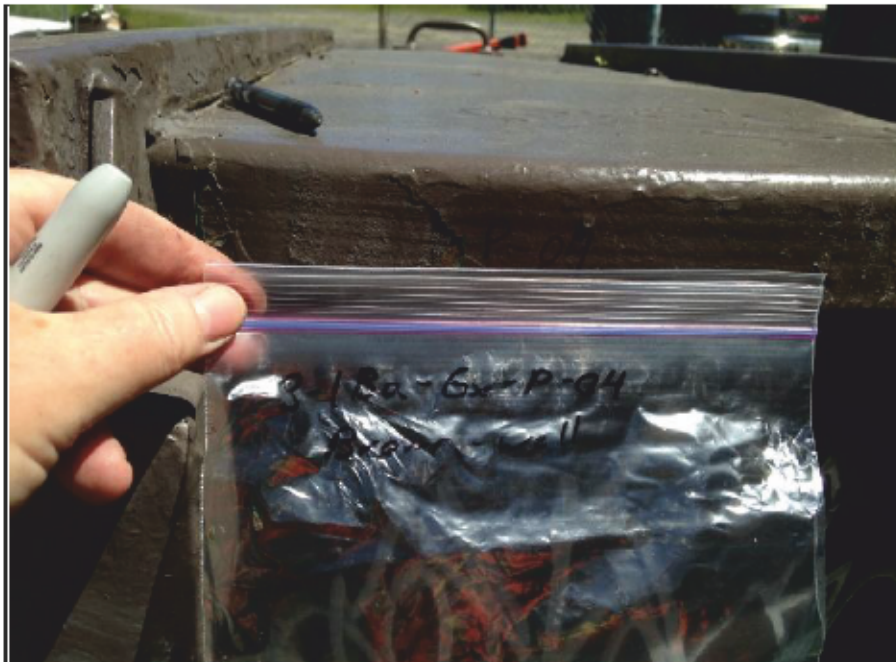
**Photo 5:**  
*Bancroft Drive  
Lift Station  
Sample #  
2811Ba-Ex-P-  
04 – Well Cover  
(brown) - 2100  
µg/g (0.21%)  
lead by dry  
weight –  
Condition - Fair*

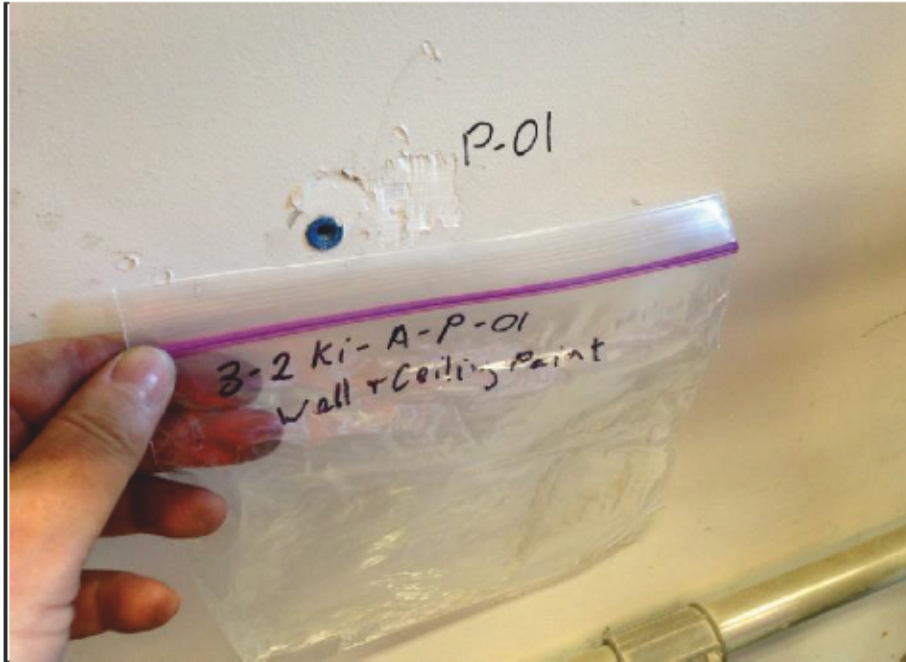
**Photo 7:**  
*Kingsway Lift Station*  
Sample #  
1955Ki-A-P-01-  
Walls and ceiling (white) -  
Result - <140 µg/g (<0.014%) lead by dry weight -  
Condition - Fair

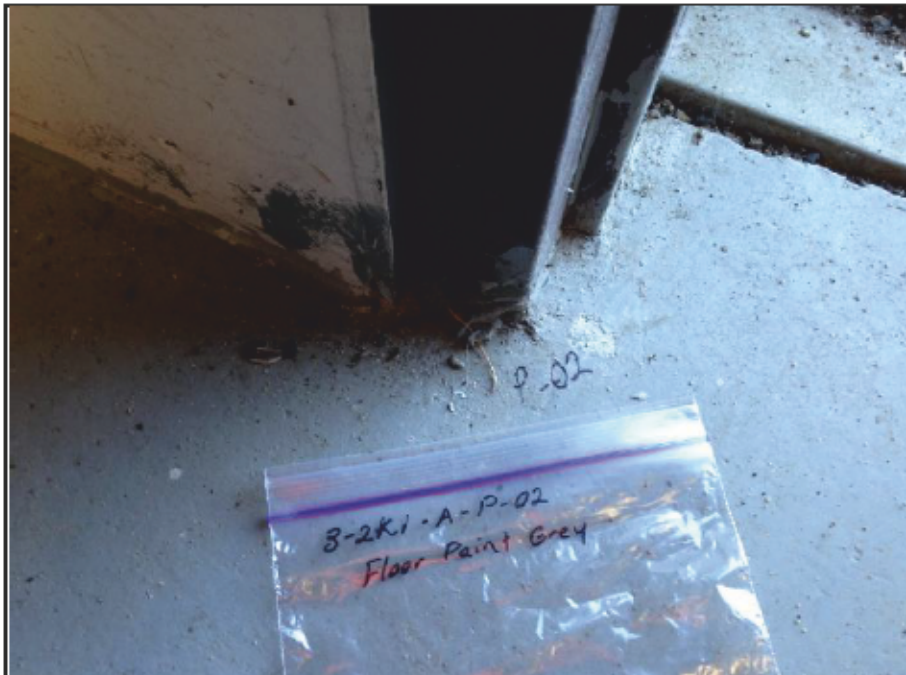
**Photo 8:**  
*Kingsway Lift Station*  
Sample #  
1955Ki-A-P-02  
- Floor (grey) -  
Result - <91 µg/g (<0.0091%) lead by dry weight -  
Condition - Fair

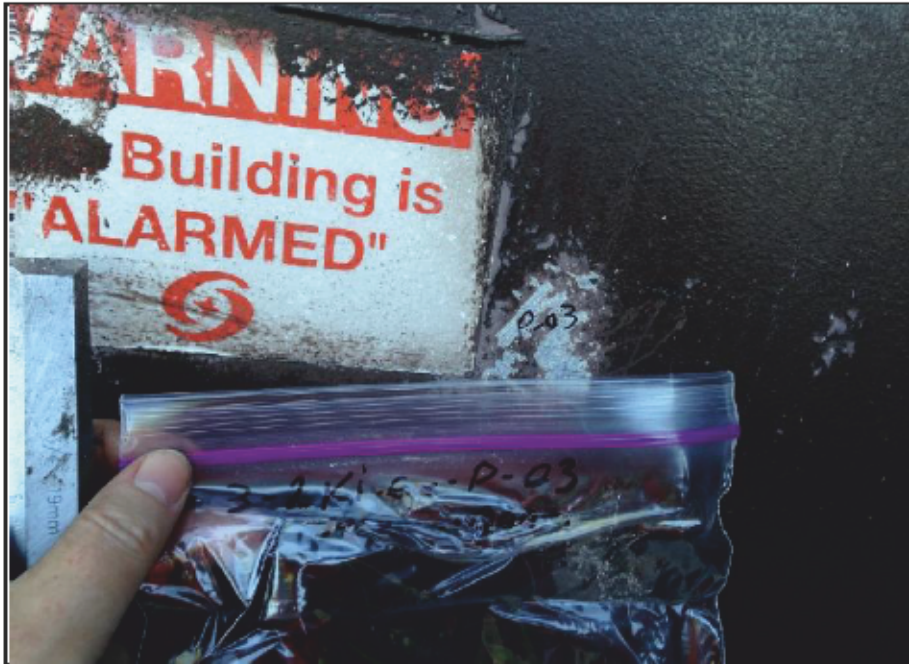
All of the samples collected were found to be below the 5,000 µg/g (0.5%) level, however, all three (3) samples tested were found to be over 90 µg/g (0.009%), which will require lead handling procedures or special precautions. The painted surfaces are considered to be in fair condition.

**Photo 9:**  
*Kingsway Lift Station*  
Sample #  
1955Ki-Ex-P-03  
– Entrance Door (Brown) - Result  
- <98 µg/g  
(<0.0098%) –  
Condition – Fair

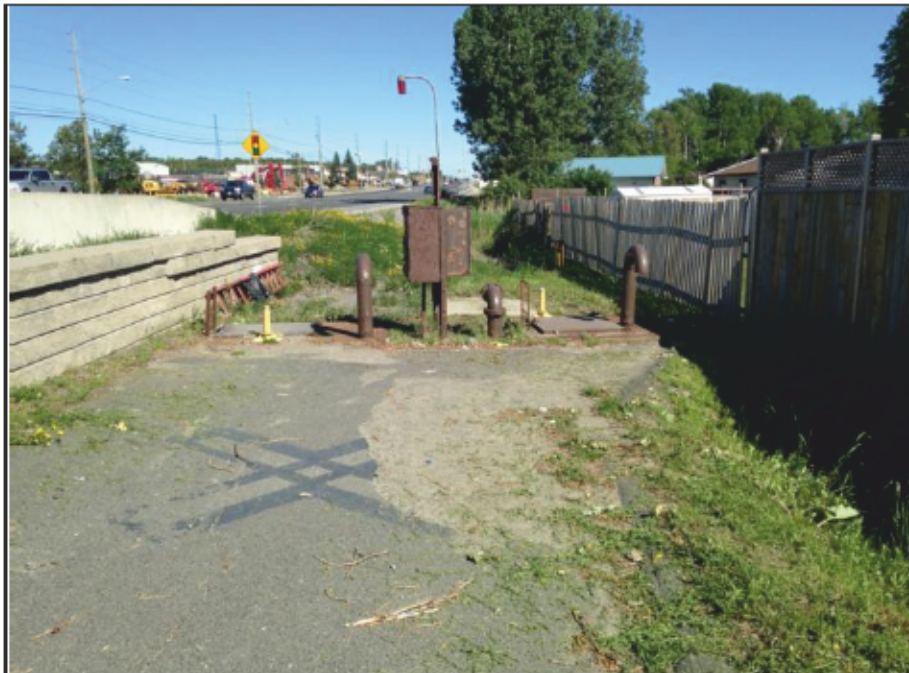
There is visually similar paint to sample 1955Ki-Ex-P-03 – Entrance Door (Brown) above, noted on the associated wet well / vents and electrical / instrumentation structures adjacent to the building, which will require lead handling procedures or special precautions (Photo 10).

**Photo 10:**  
*Kingsway Lift Station*  
Wet well / vents and electrical / instrumentation structure contains visually similar paint to sample 1955Ki-Ex-P-03 – Entrance Door (Brown) - Result - <98 µg/g (<0.0098%) above

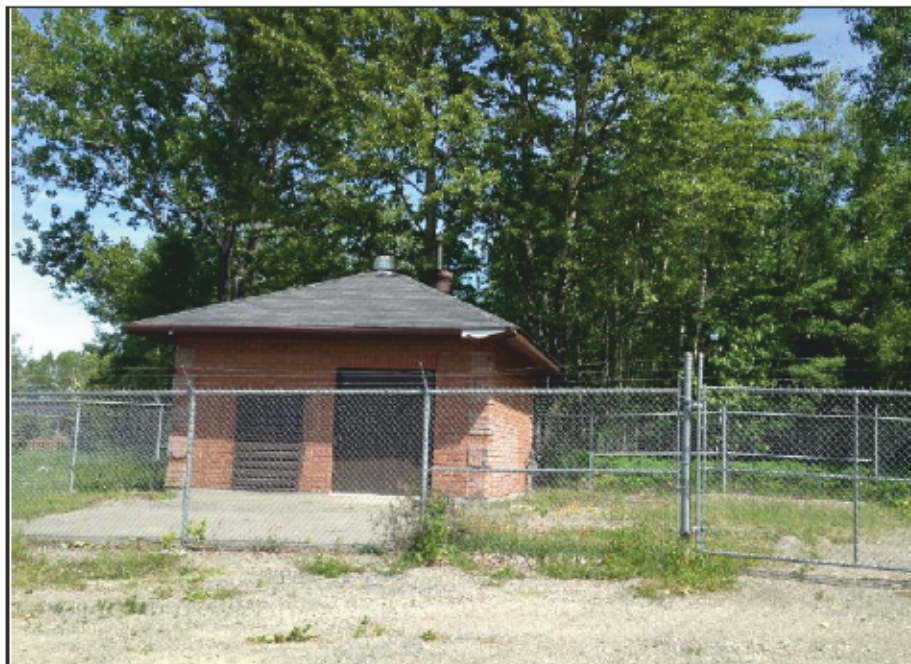
**Photo 11:**  
*Hudson Rd. Lift Station* – exterior brown paint located on vent (14 000 µg/g or 1.4% lead by dry weight).

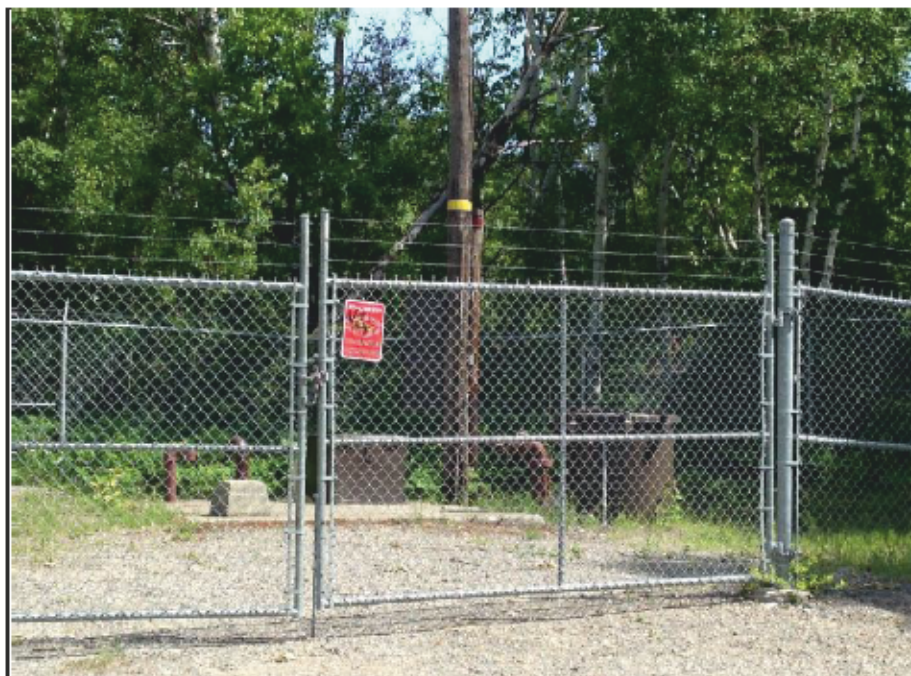
Sample (2226Hu-Ex-P-03) Entrance Door (Brown) had an insufficient quantity of material and therefore could not be tested. Visually similar brown paint was sampled at the Bancroft and Kingsway Lift Stations and was found to be over 90 µg/g (0.009%) lead by weight, which will require lead handling procedures or special precautions. The brown paint at the Hudson Lift Station and associated wet well / vents and electrical / instrumentation structures adjacent to the building, will require lead handling procedures or special precautions (Photo 12).

**Photo 12:**  
*Hudson Rd. Lift Station* – Exterior brown paint on associated wet well / vents and electrical / instrumentation structure contains visually similar paint to sample 1955Ki-Ex-P-03 – Entrance Door (Brown) - Result - <98 µg/g (<0.0098%)
