Township of South Stormont

Ingleside WWTP, 14754 County Road 2, Ingleside

Full Site DSR

Project #: 9987
Date: August 2019

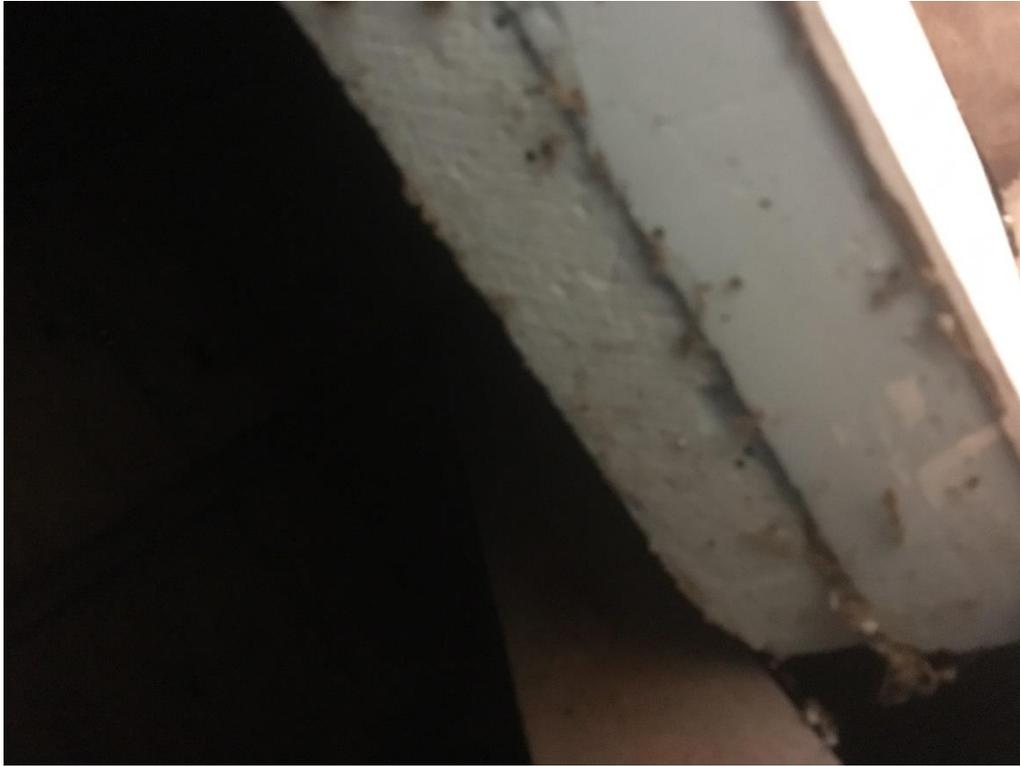
- Three samples of insulation were collected for analysis of ACM content. This insulation can be found in the attic of the Centrifuge Building.
- One sample of Yellow Paint 'A' was collected for the analysis of Lead content. This paint can be found on gas pipe on the 2nd floor of the Centrifuge Building.

Figure 1 – SLU-ATT-Insul A, B and C Sample Location

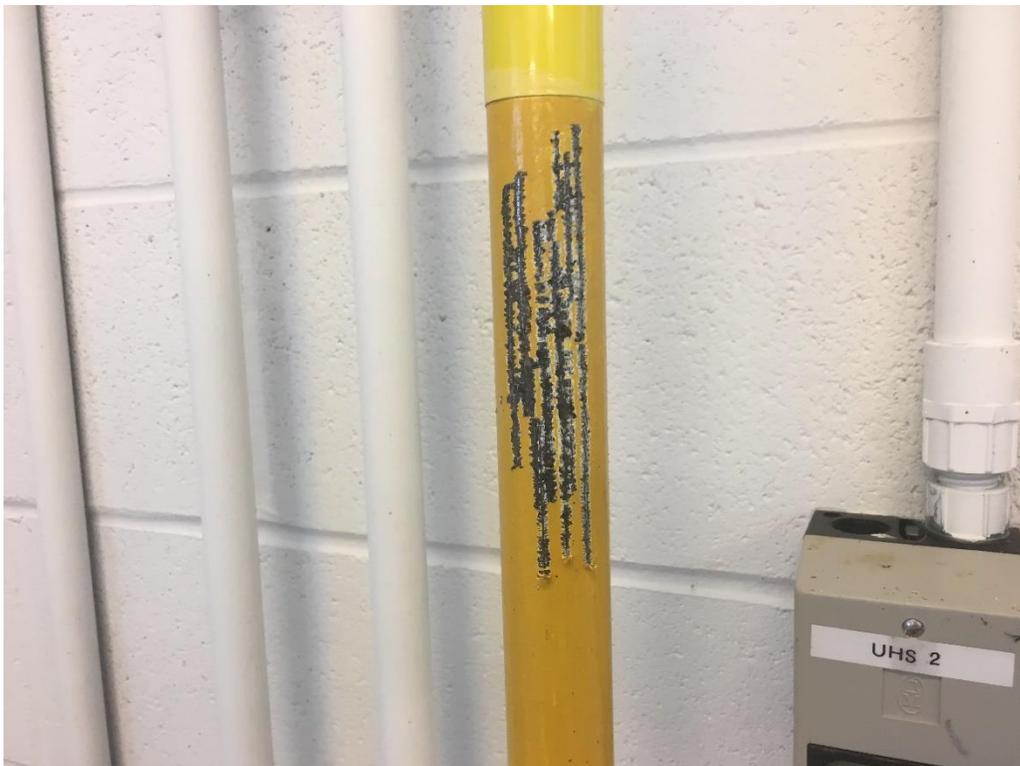
Figure 2 – SLU-2ND-Paint Yellow A Sample Location

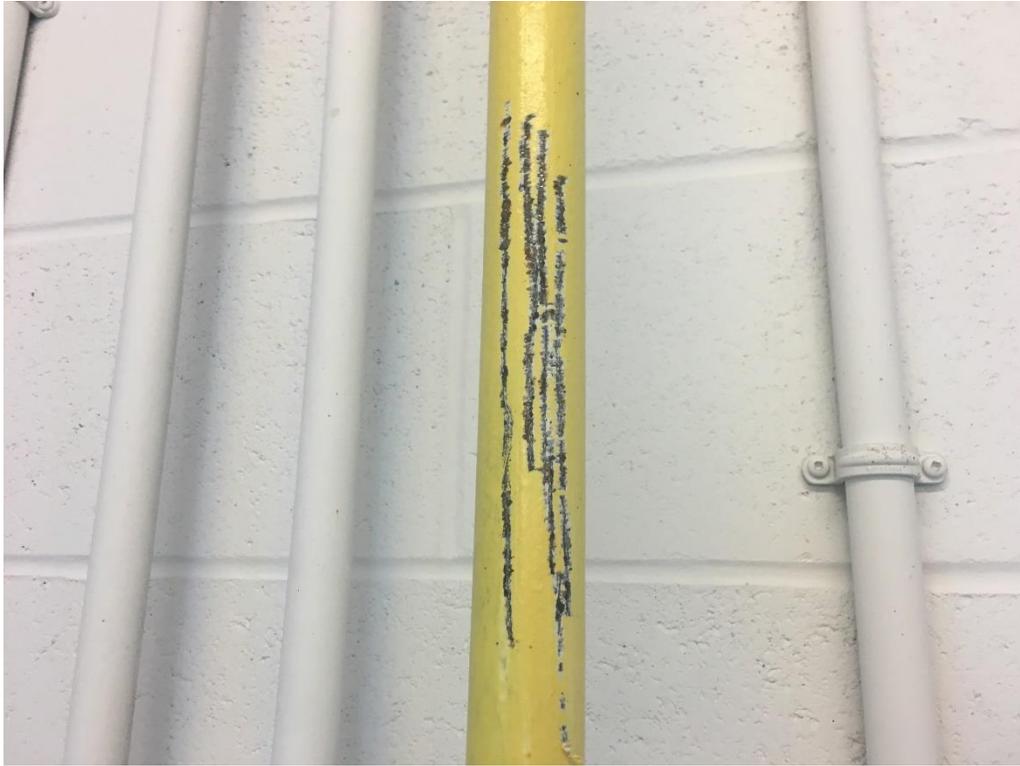
- One sample of Yellow Paint 'B' was collected for the analysis of Lead content. This paint can be found on gas pipe on the 2nd floor of the Centrifuge Building.

Figure 3 – SLU-2ND-Paint Yellow B Sample Location

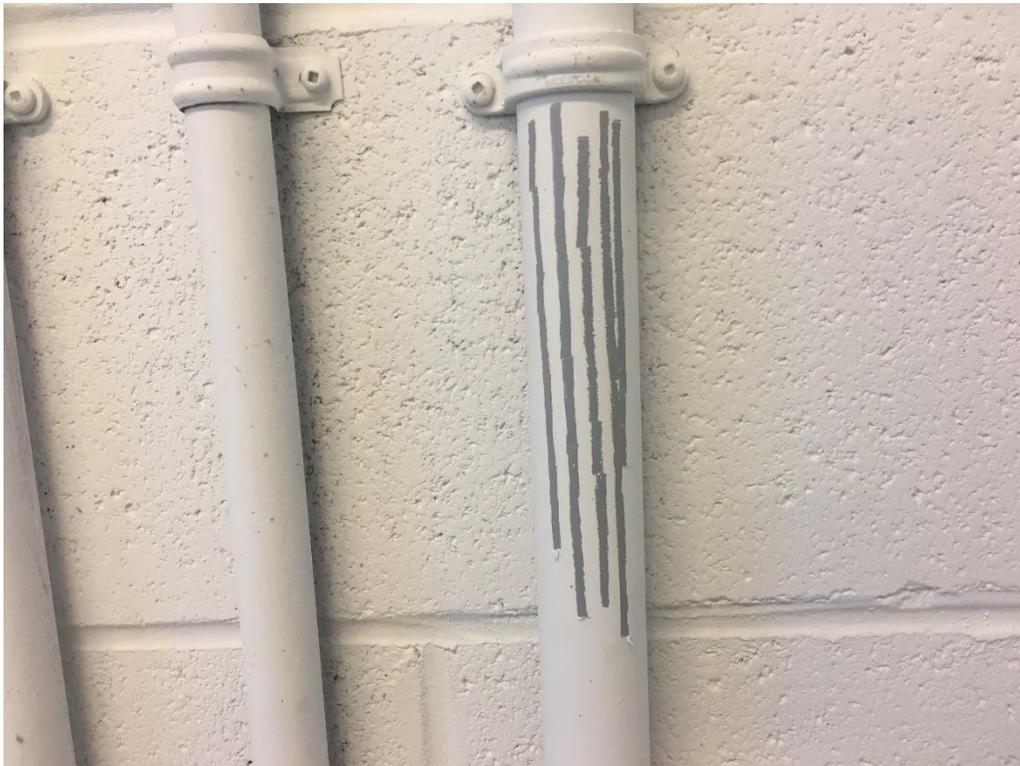
- One sample of White Paint was collected for the analysis of Lead content. This paint can be found on the walls and multiple conduits on the 2nd floor of the Centrifuge Building.

Figure 4 – SLU-2ND-Paint White Sample Location

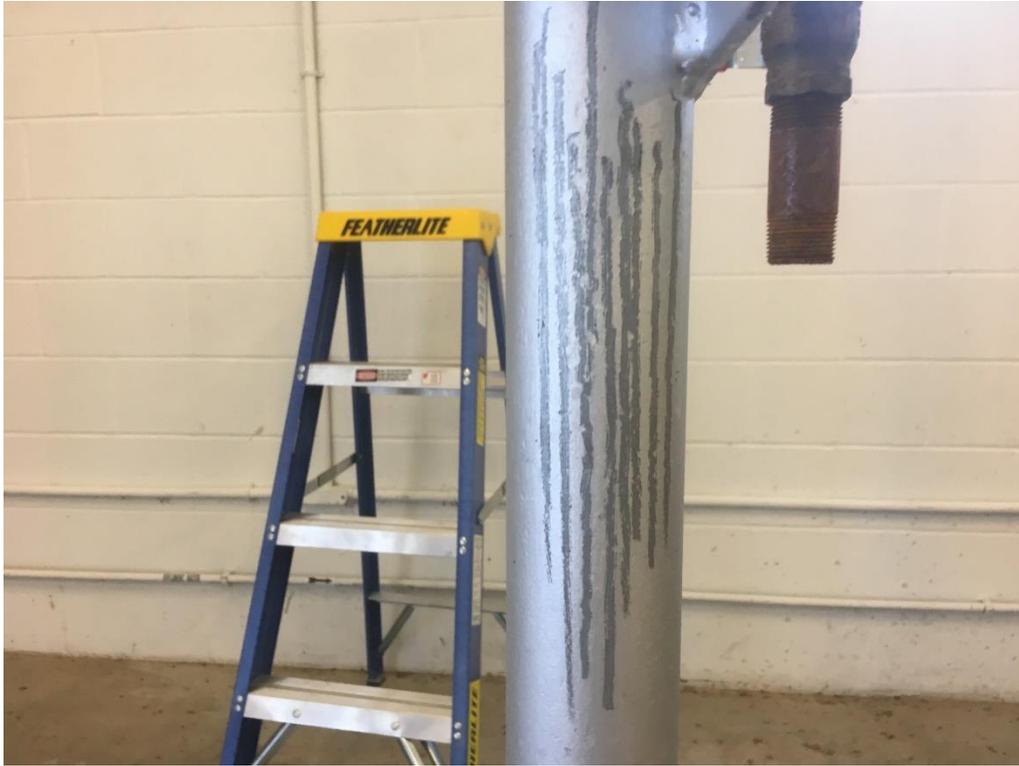
- One sample of Silver Paint was collected for the analysis of Lead content. This paint can be found on multiple metal poles on the 2nd floor of the Centrifuge Building.

Figure 5 – SLU-2ND-Paint Silver Sample Location

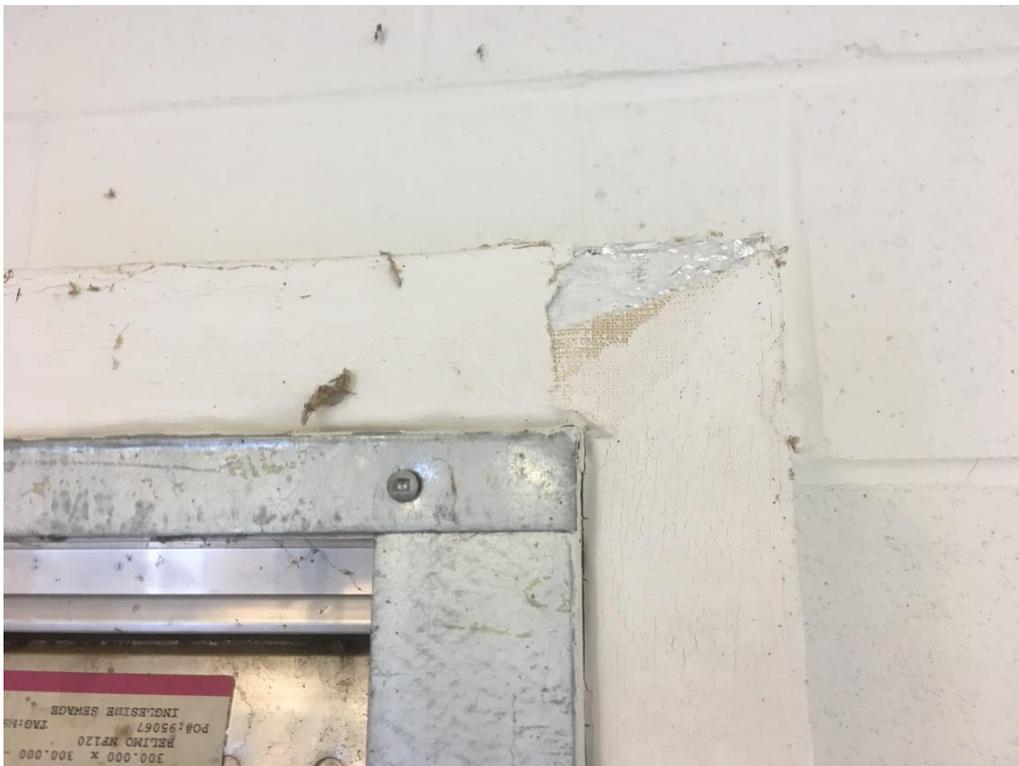
- Three samples of fan cladding were collected for analysis of ACM content. This material can be found on the exterior of a fan located on the 2nd floor of the Centrifuge building.

Figure 6 – SLU-2ND-Fan Cladding A, B and C Sample Location

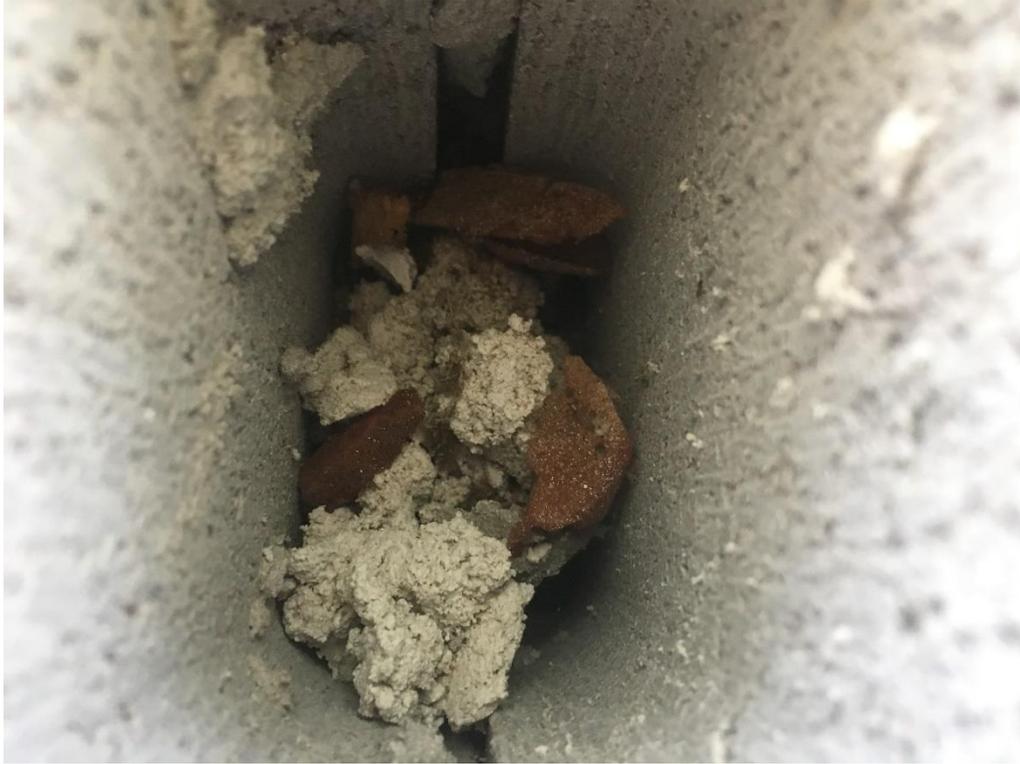
- Three samples of spray foam were collected for analysis of ACM content. This material can be found inside the block wall near the window on the 2nd floor of the Centrifuge Building.

Figure 7 – SLU-2ND-Spray Foam A, B and C Sample Location

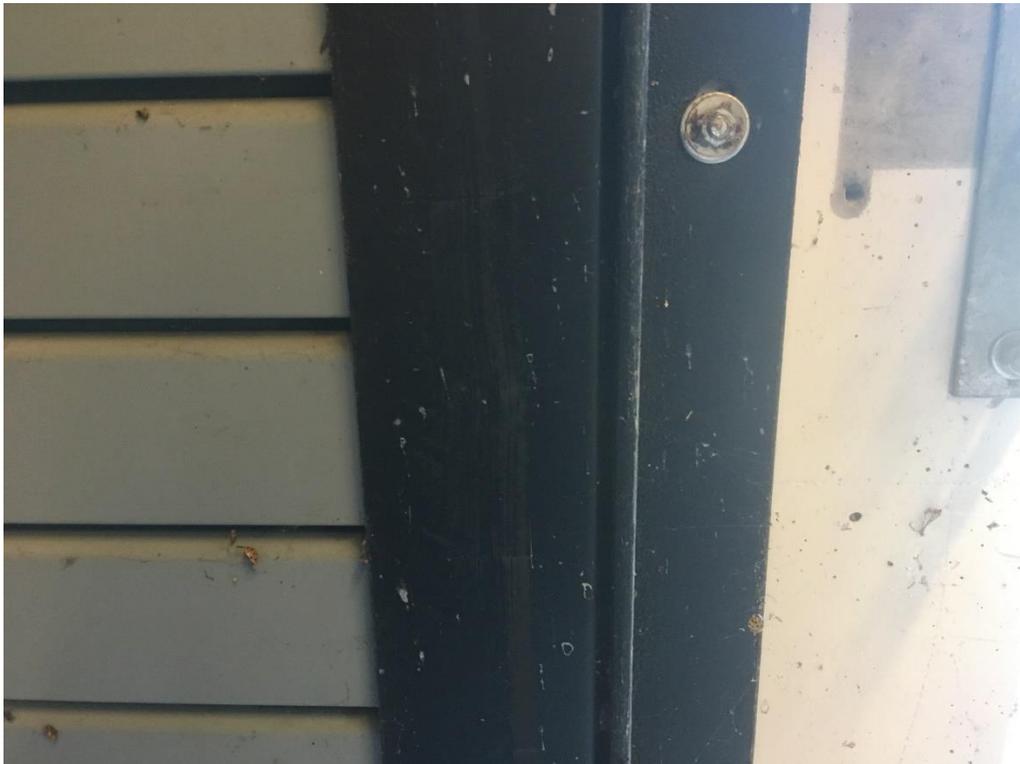
- One sample of black paint was collected for the analysis of Lead content. This paint can be found directly inside the garage door for the 1st floor of the Centrifuge Building.

Figure 8 – SLU-1ST-Paint Black Sample Location

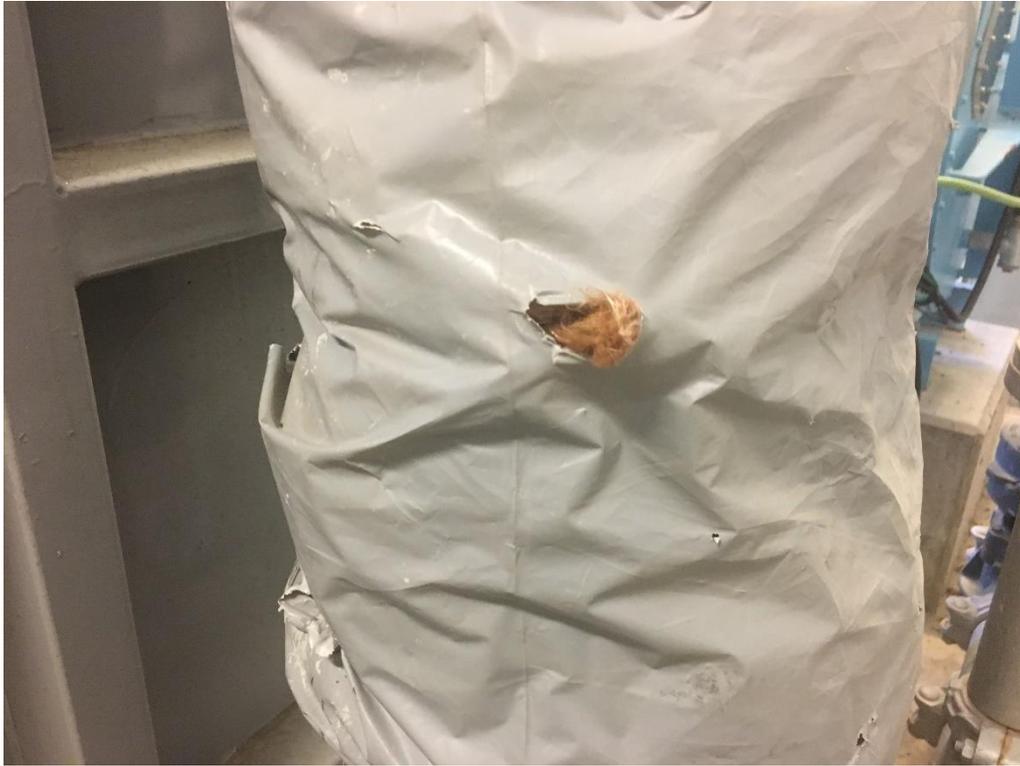
- Three samples of insulation were collected for analysis of ACM content. This insulation can be found surrounding a large pipe on the 1st floor of the Centrifuge Building.

Figure 9 - SLU-1ST-Insulation A, B and C Sample Location

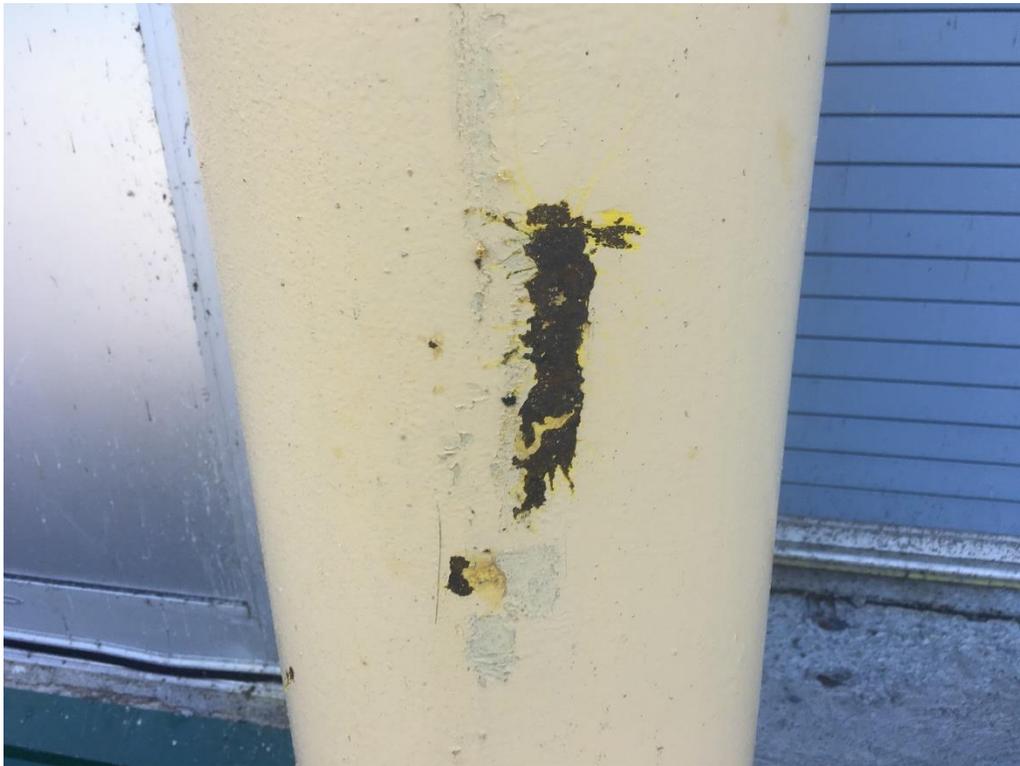
- One sample of yellow paint was collected for the analysis of Lead content. This paint can be found on a bollard located directly outside the Centrifuge Building.

Figure 10 – SLU-EXT-Paint Yellow Sample Location

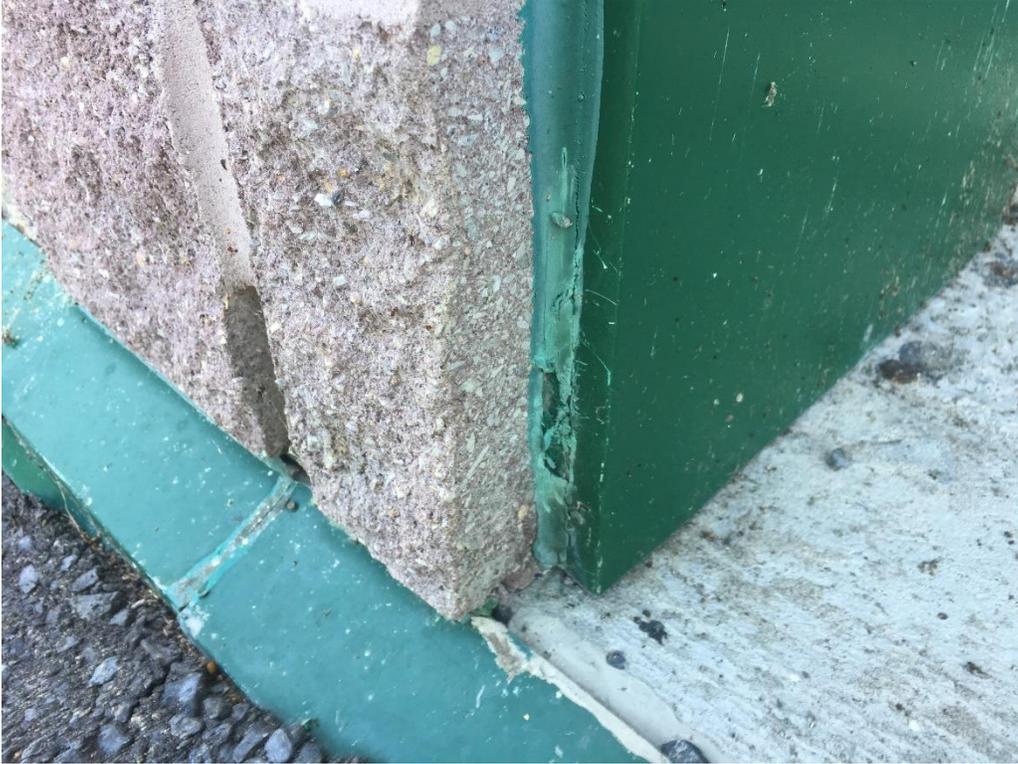
- Three samples of caulking were collected for analysis of ACM content. This caulking can be found on multiple joints/cracks on the exterior of the Centrifuge Building.

Figure 11 – SLU-EXT-Caulking A, B and C Sample Location

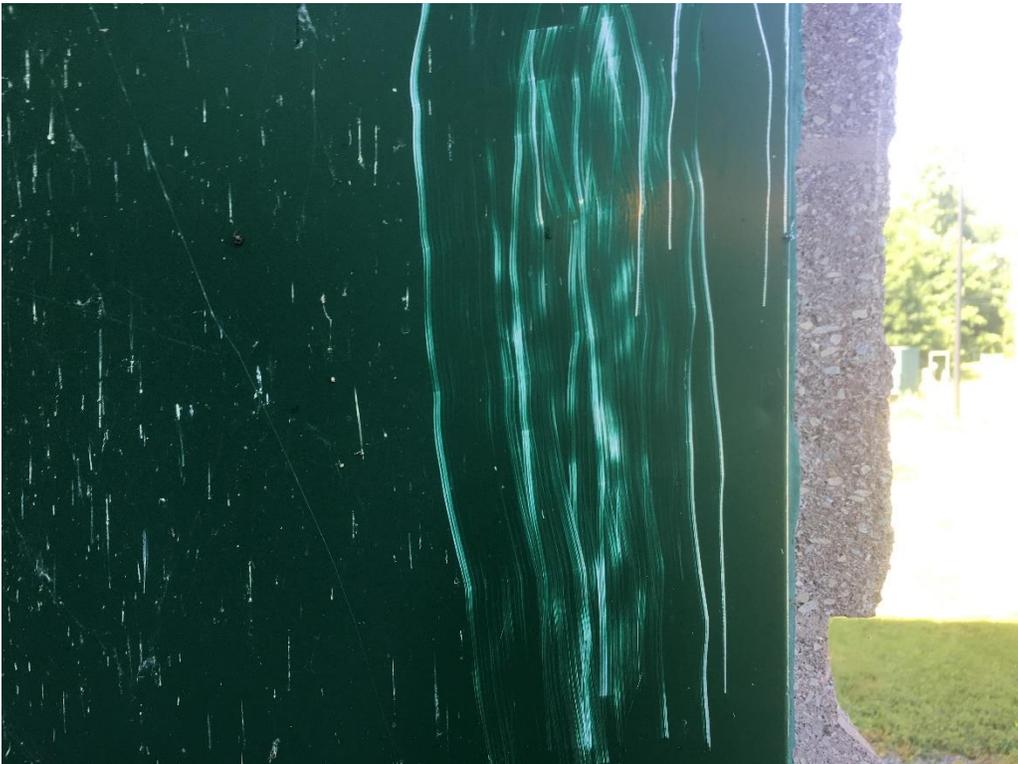
- One sample of powder coat green paint was collected for the analysis of Lead content. This paint can be found on exterior flashing of the Centrifuge Building.

Figure 12 – SLU-EXT-Powdercoat Green Sample Location

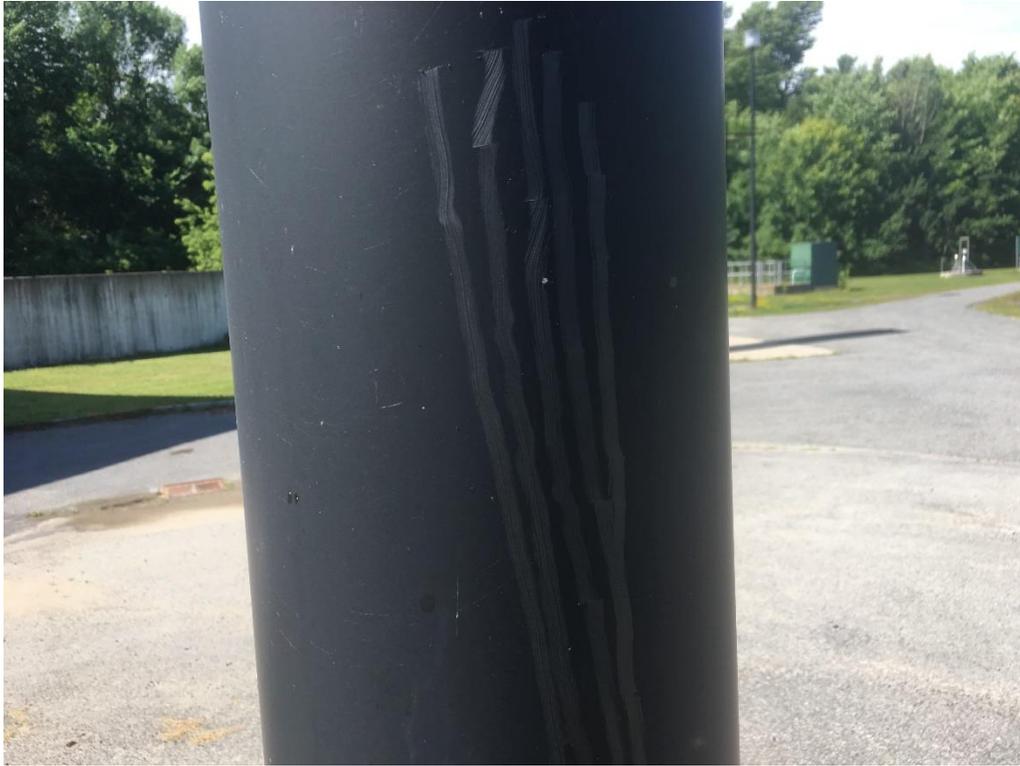
- One sample of powder coat black paint was collected for the analysis of Lead content. This paint can be found on a light standard located just North of the Centrifuge Building.

Figure 13 – SLU-EXT-Powdercoat Black Sample Location

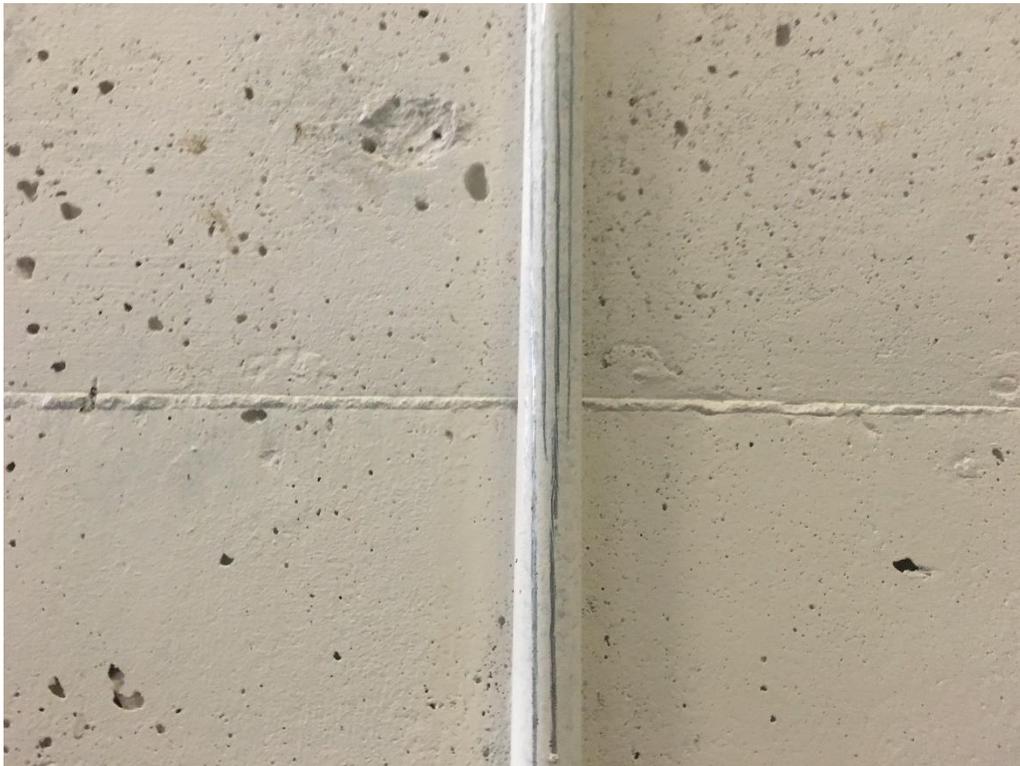
Figure 14 – AER-Tank-Paint Off-White Sample Location

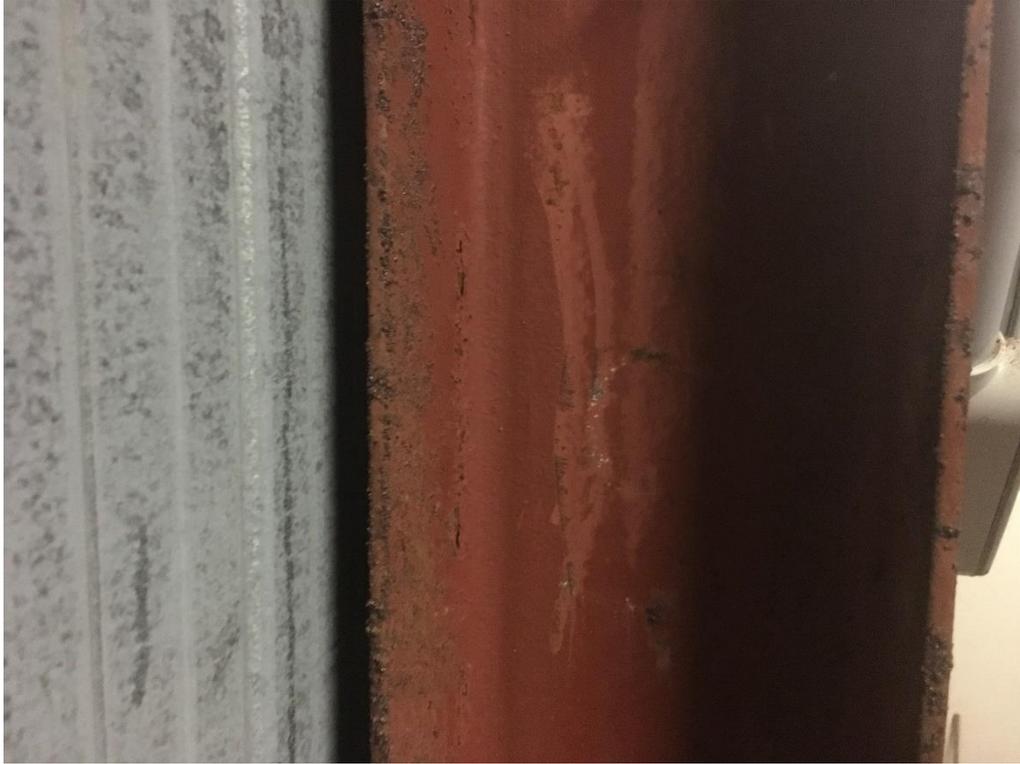
Figure 15 – AER-Tank-Primer Sample Location

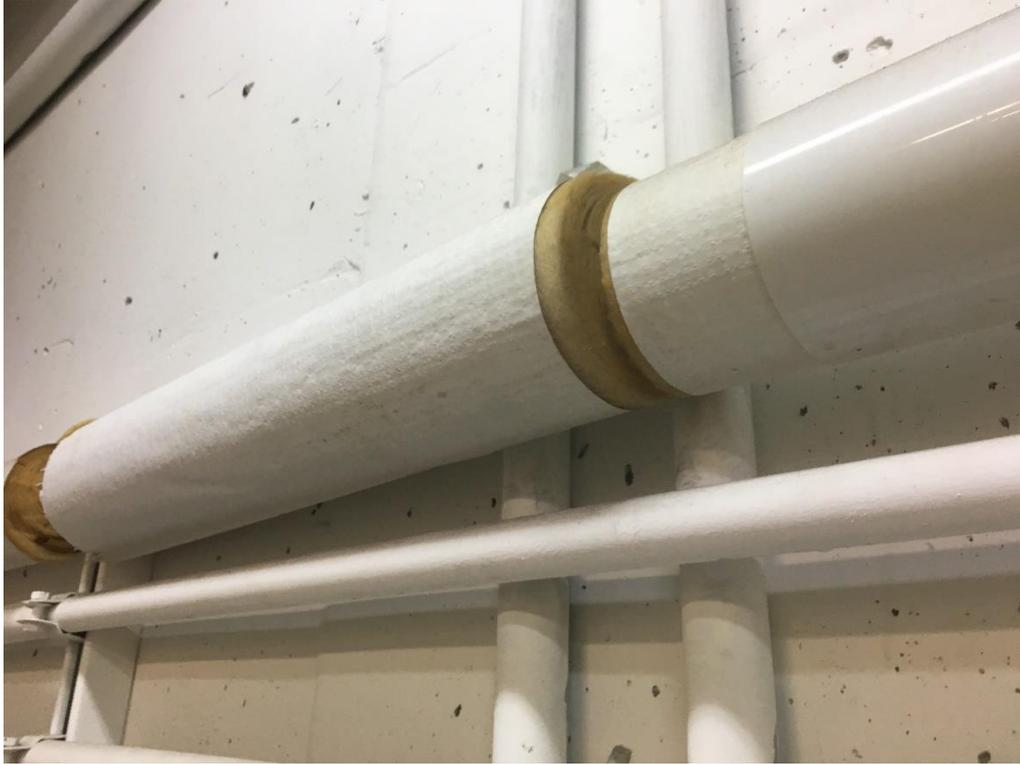
Figure 17 – Observed Fiberglass Insulation, no need to sample

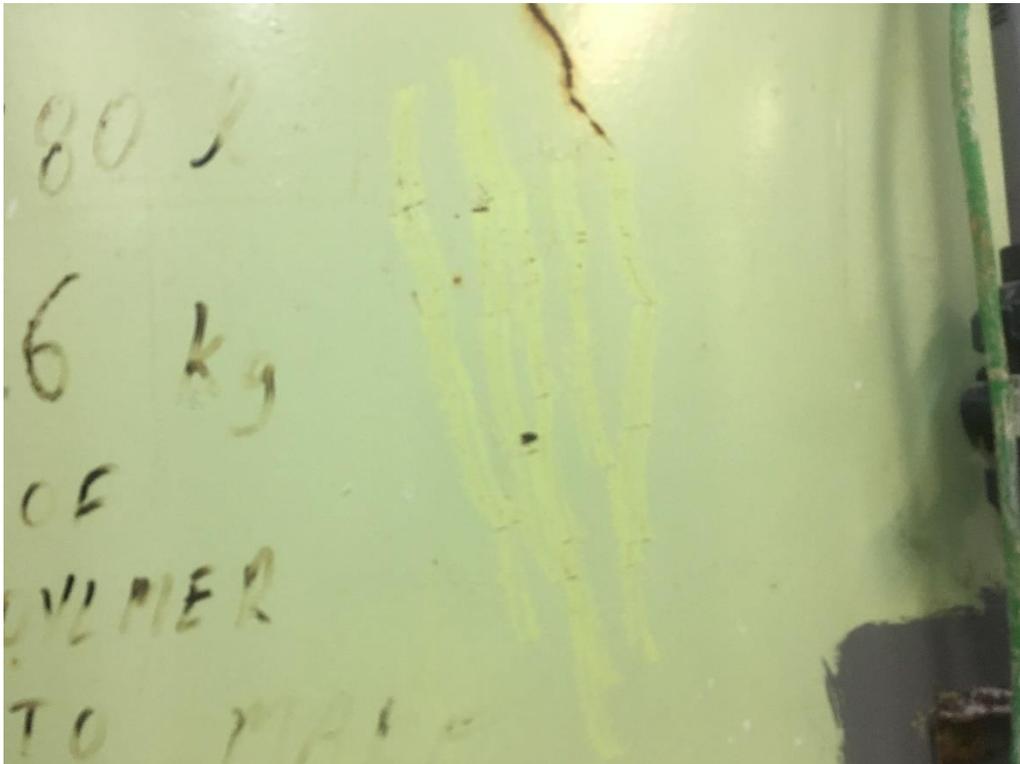
- One sample of light green paint was collected for the analysis of Lead content. This paint can be found on a tank located inside the Secondary Clarifier #2 room of the Equipment Building.

Figure 18 –AER-CL2-Pump-Paint Lt Green Sample Location

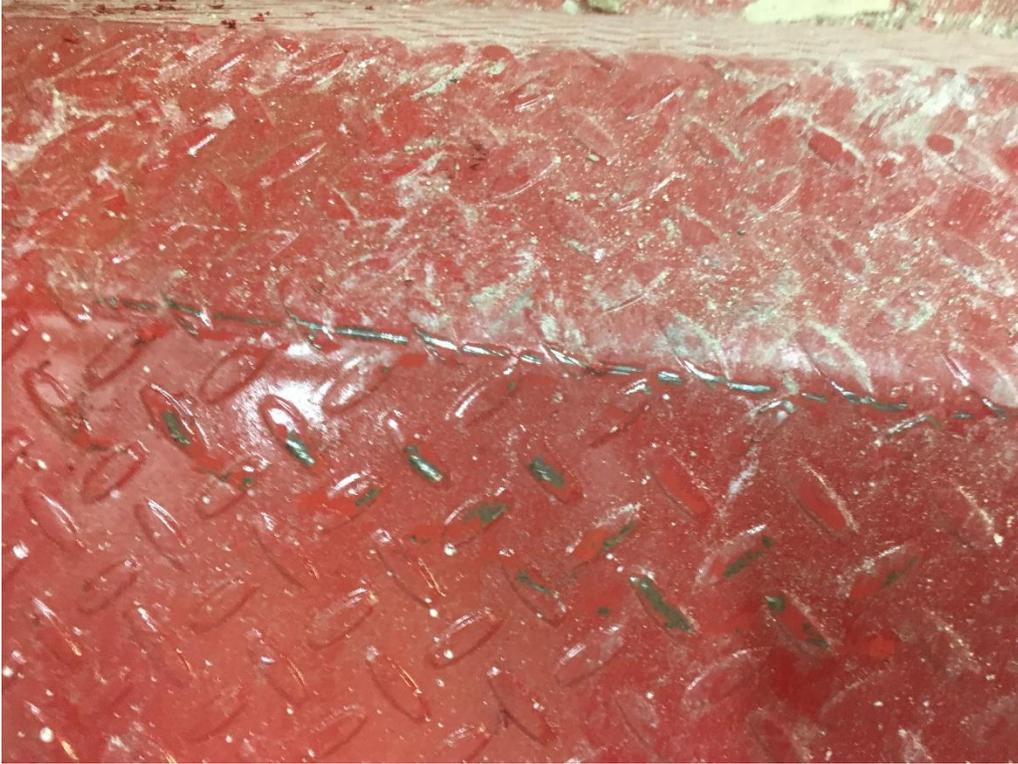
- One sample of red paint was collected for the analysis of Lead content. This paint can be found on a conduit/line cover located on the floor of the Secondary Clarifier #2 room of the Equipment Building.

Figure 19 – AER-CL2-Paint Red Sample Location

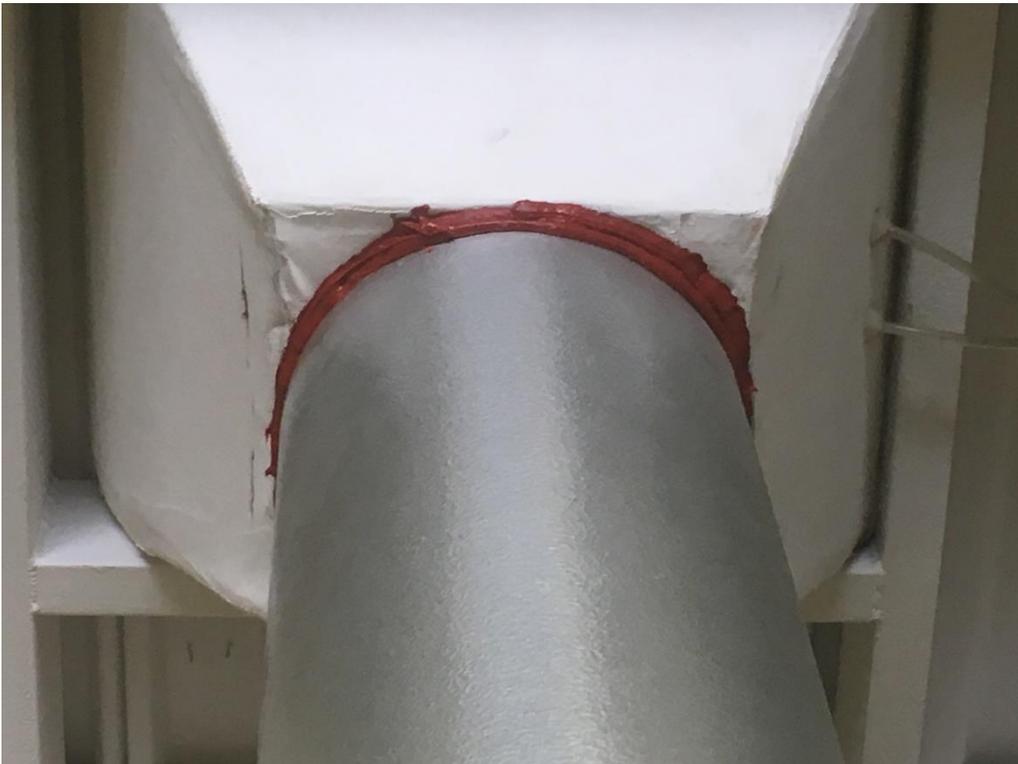
Figure 20 – Observed firestopping <5 years old, no need to sample

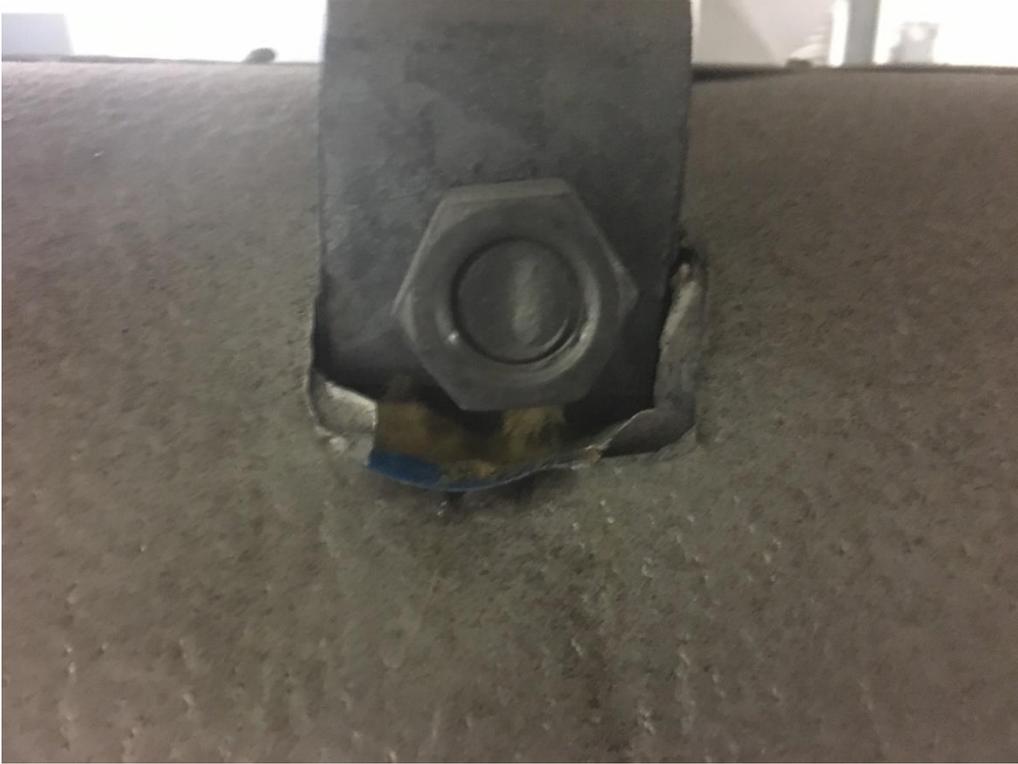
Figure 21 – Observed Fiberglass Insulation around pipe, no need to sample

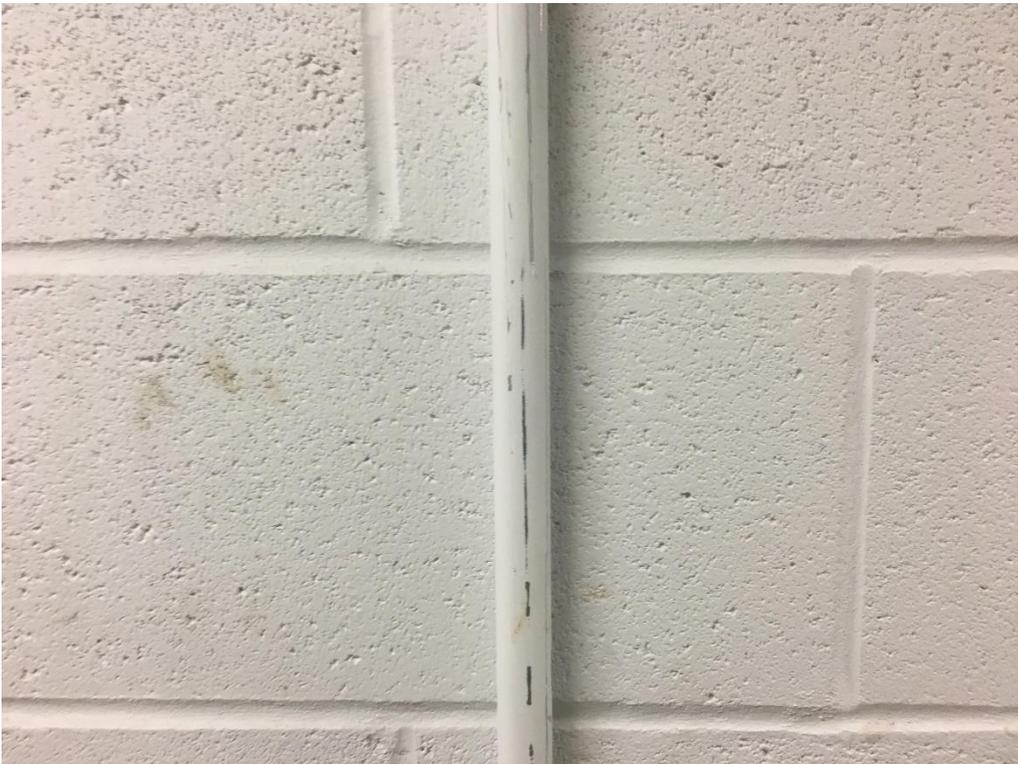
Figure 22 –AER-Sludge-Paint White Sample Location

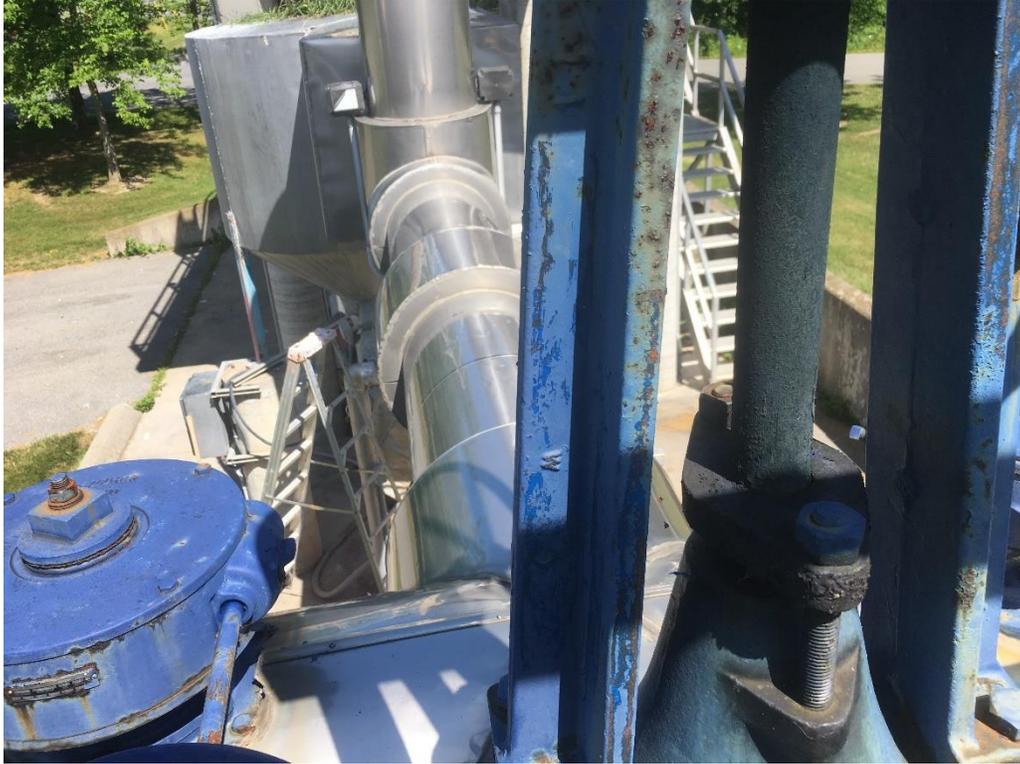
- One sample of white paint was collected for the analysis of Lead content. This paint can be found on the interior walls of the Equipment Building.
- One sample of blue paint was collected for the analysis of Lead content. This paint can be found on exterior equipment located directly North of the Aeration Tanks.

- Three samples of caulking were collected for analysis of ACM content. This caulking can be found on/around exterior equipment located directly North of the Aeration Tanks.

Figure 23 – AER-Basin-Paint Blue & AER-Basin-Caulking A, B and C Sample Location

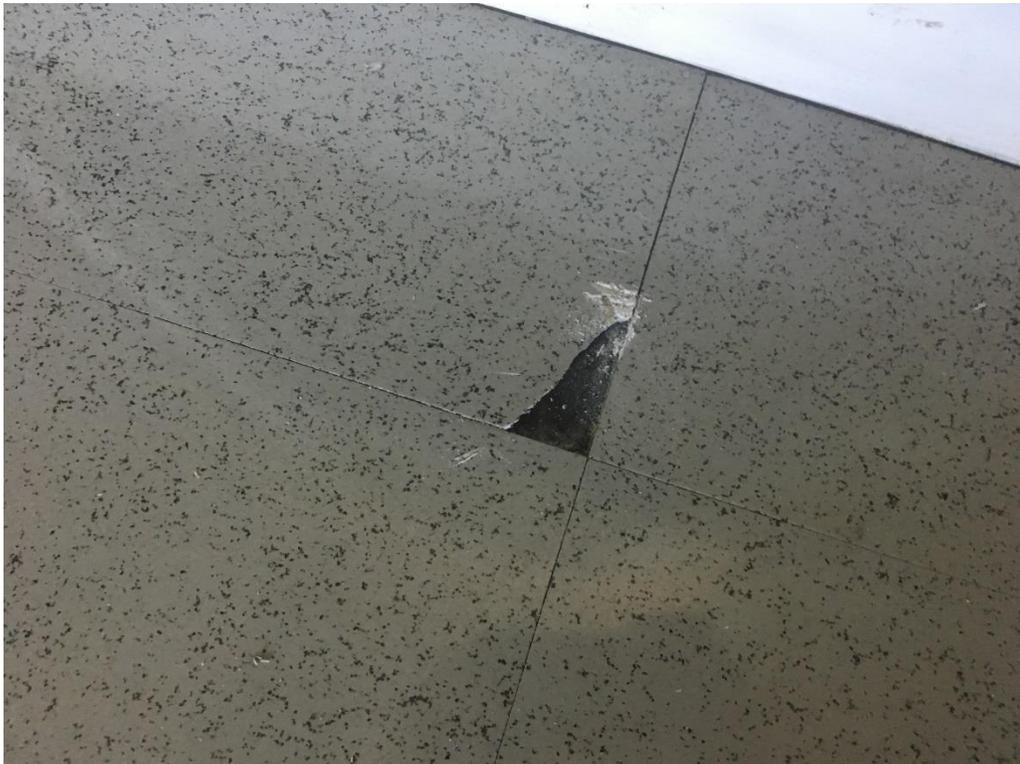
- Three samples of floor tile were collected for analysis of ACM content. These floor tiles can be found on the floor of the office located inside the Administration Building.

Figure 24 – ADM-OFF-Floor Tile A, B and C Sample Location

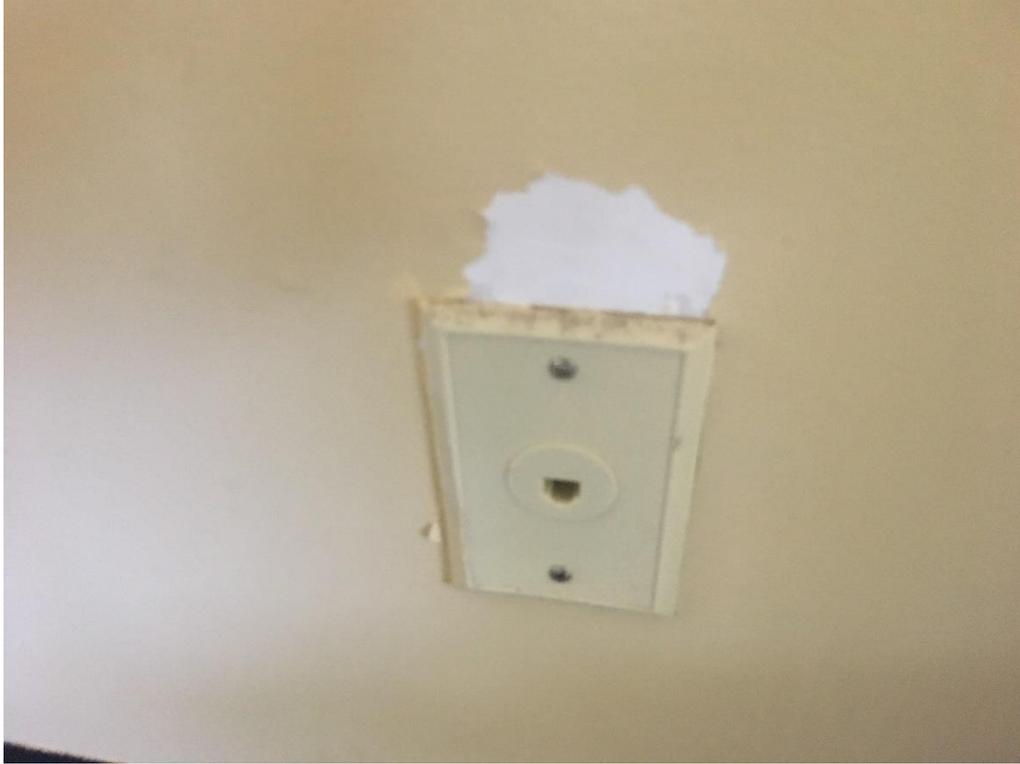
- One sample of gold paint was collected for the analysis of Lead content. This paint can be found on some interior walls of the Administration Building including but not limited to the office, the lunchroom and the men's washroom.

Figure 25 – ADM-OFF-Paint Gold Sample Location

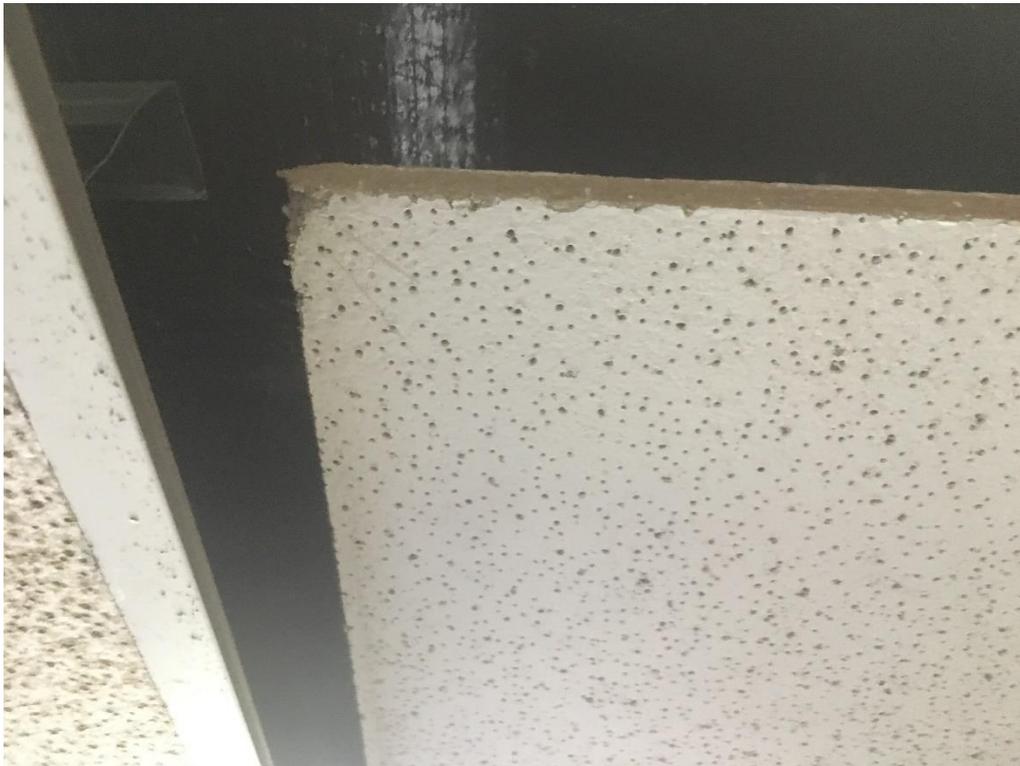
- Three samples of ceiling tile were collected for analysis of ACM content. These ceiling tiles can be found throughout ceiling of the Administration Building.

Figure 26 – ADM-OFF-Ceiling Tile A, B and C Sample Location

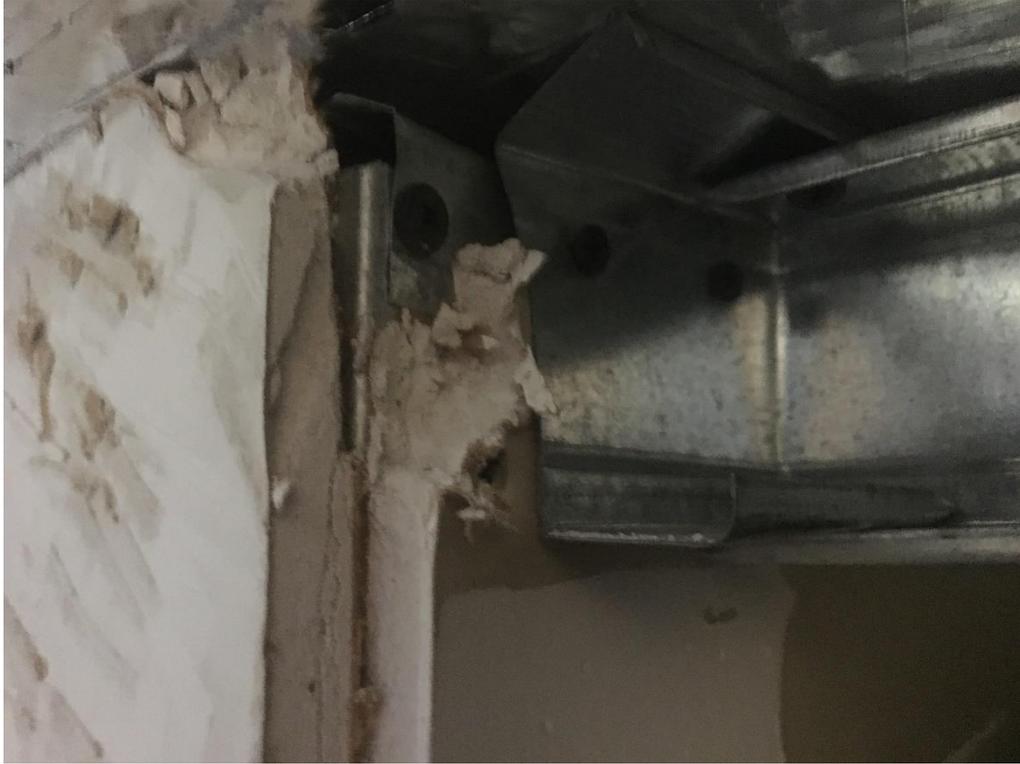
- Three samples of drywall (wallboard) were collected for analysis of ACM content. This material can be found throughout the walls of the Administration Building.

Figure 27 – ADM-OFF-Wallboard A, B and C Sample Location

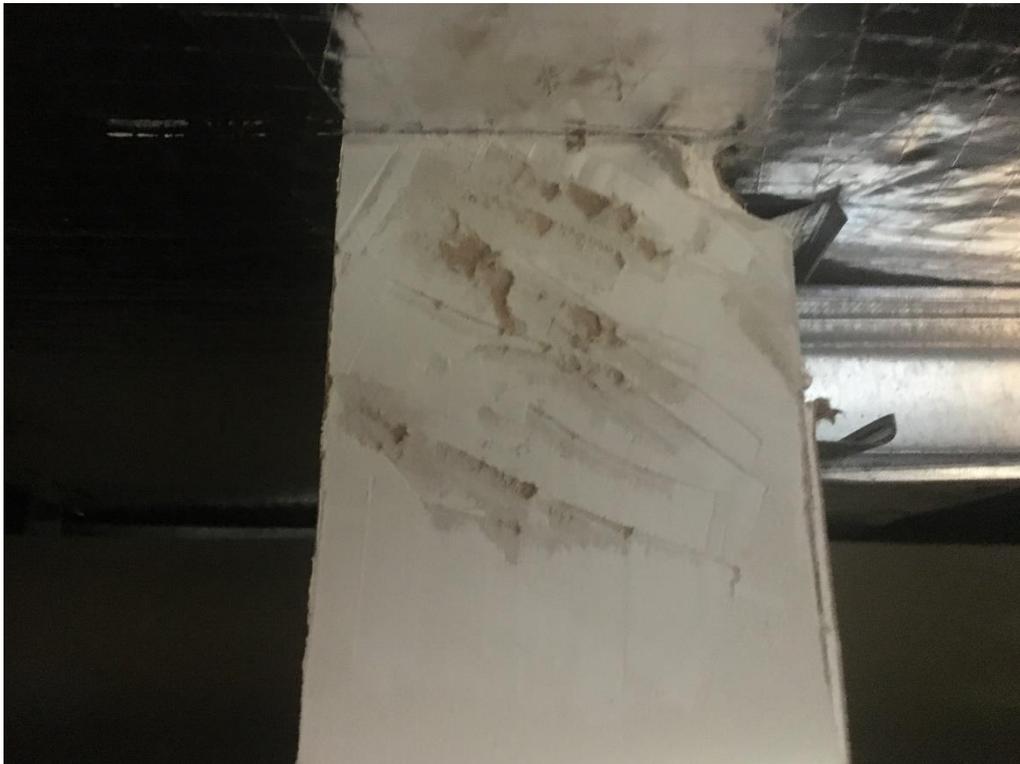
- Three samples of drywall joint compound (DWJC) were collected for analysis of ACM content. This material can be found throughout the walls of the Administration Building.

Figure 28 – ADM-OFF-DWJC A, B and C Sample Location
