Township of South Stormont

Ingleside WWTP, 14754 County Road 2, Ingleside

Full Site DSR

Project #: 9987
Date: August 2019

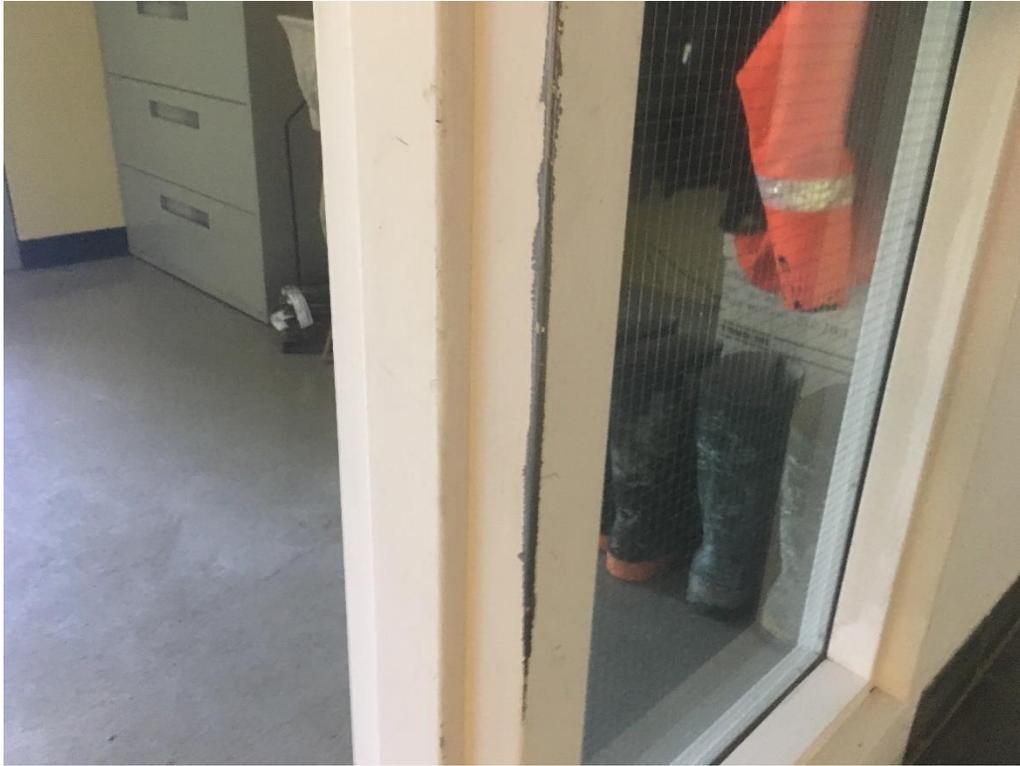
Figure 29 – ADM-LOB-Paint White Sample Location

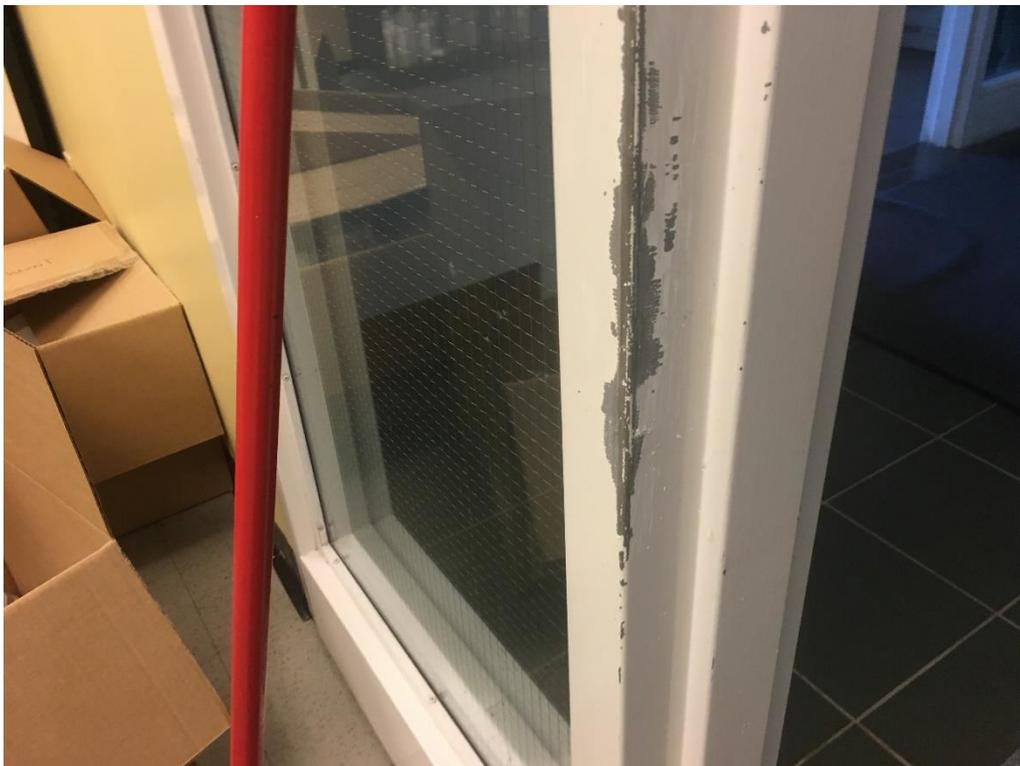
- One sample of white gloss paint was collected for the analysis of Lead content. This paint can be found on the door frame of the Administration Building's lunchroom.

Figure 30 – ADM-LUN-Paint White Gloss Sample Location

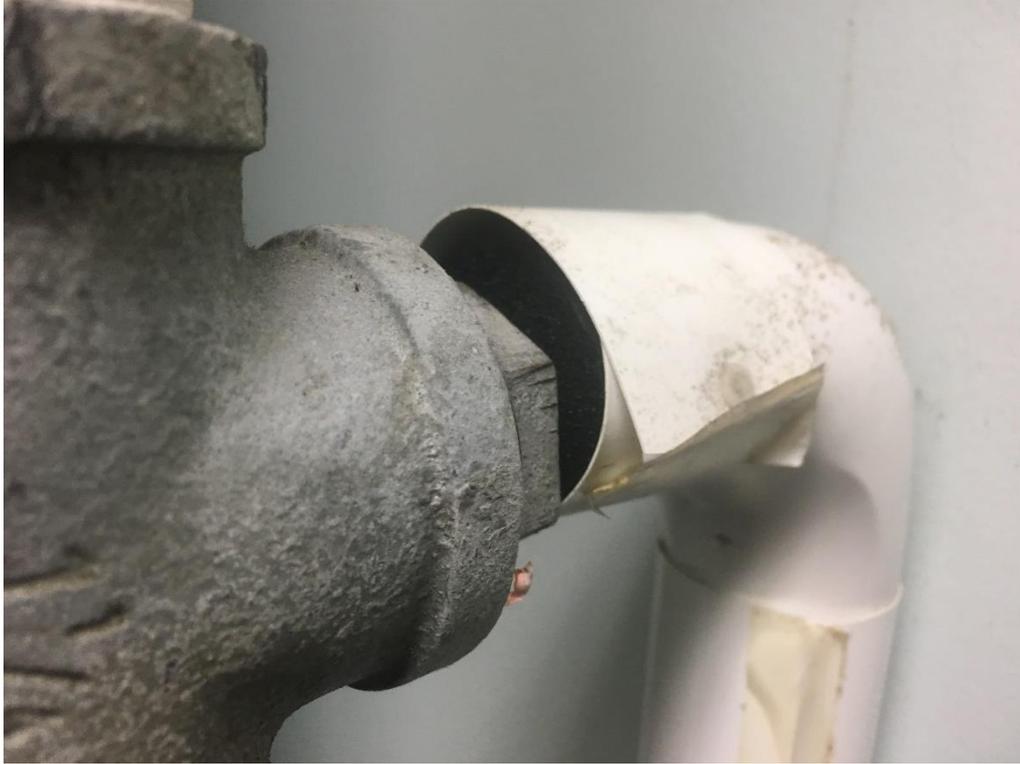
Figure 31 – Observed black foam insulation around pipe, no need to sample

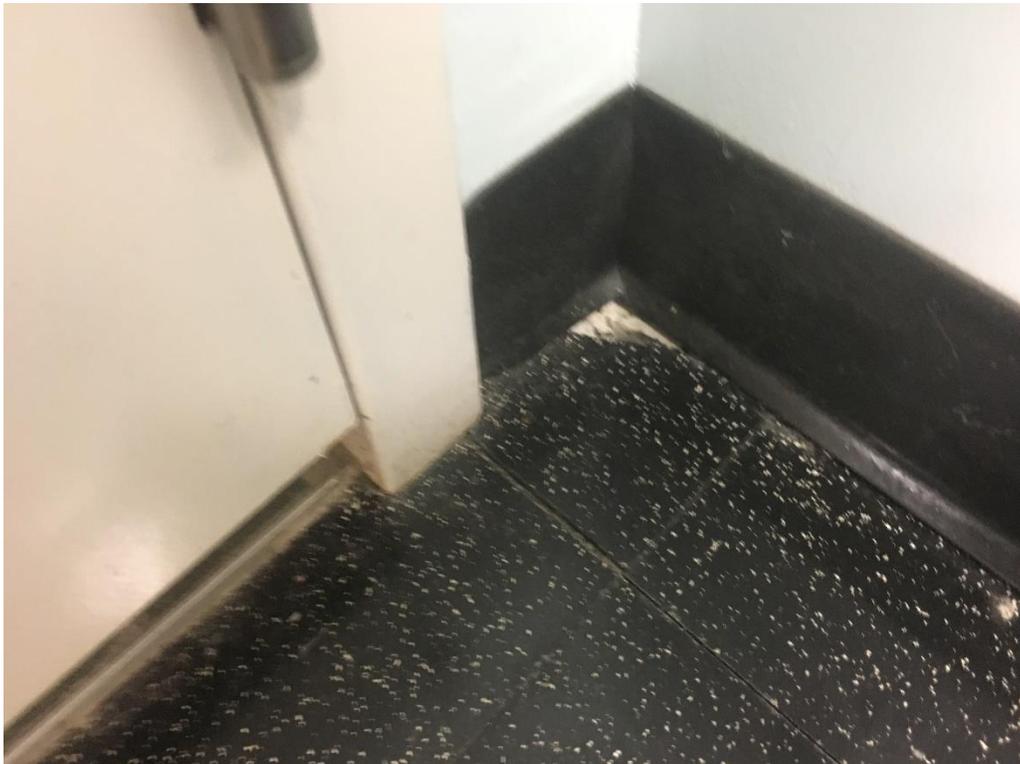
- Three samples of floor tile were collected for analysis of ACM content. These floor tiles can be found on the floor of the lab located inside the Administration Building.

Figure 32 – ADM-LAB-Floor Tile A, B and C Sample Location

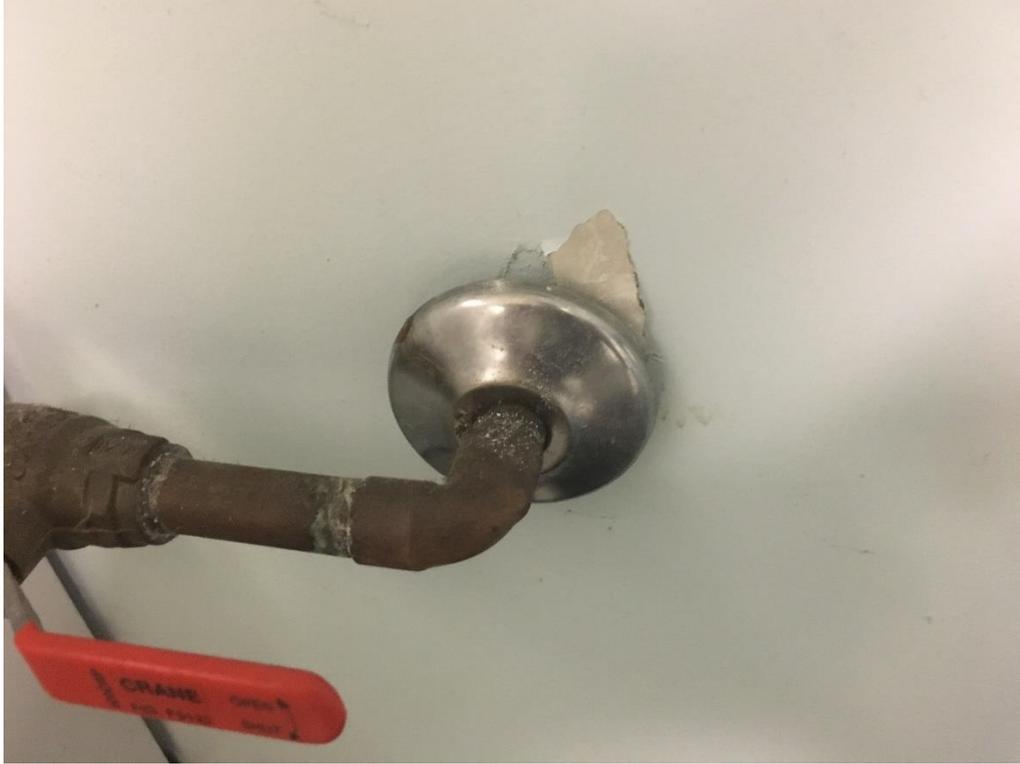
- One sample of light blue paint was collected for the analysis of Lead content. This paint can be found on the walls of the Administration Building's lab.

Figure 33 – ADM-LAB-Paint Light Blue Sample Location

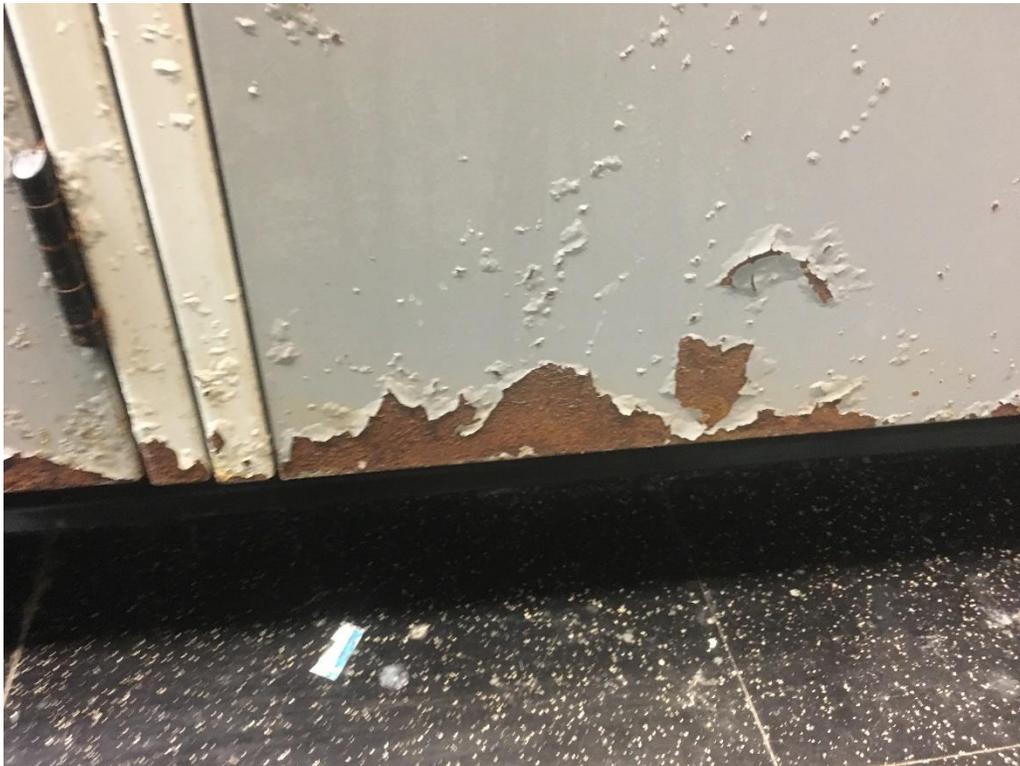
- One sample of grey paint was collected for the analysis of Lead content. This paint can be found on the cupboards of the Administration Building's lab.

Figure 34 – ADM-LAB-Paint Grey Sample Location

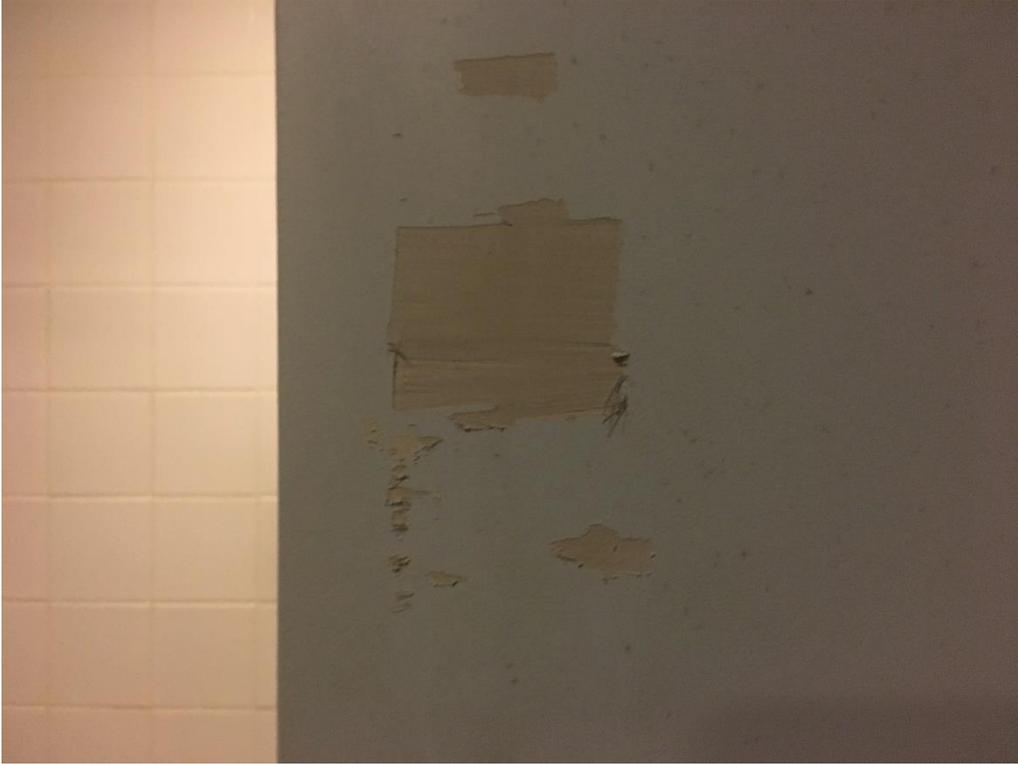
- One sample of light blue paint was collected for the analysis of Lead content. This paint can be found on the walls of the Administration Building's men's changeroom and janitor's closet.

Figure 35 – ADM-ML-Paint Light Blue Sample Location

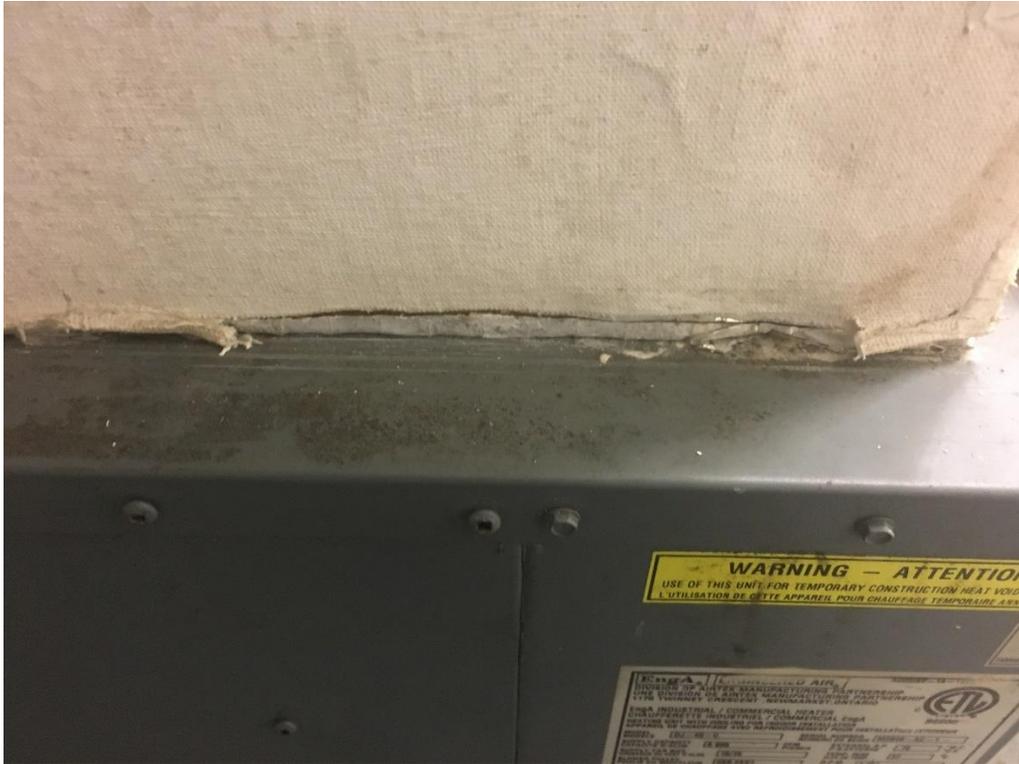
- Three samples of cladding were collected for analysis of ACM content. This cladding can be found on the exterior of multiple ducts located inside the Administration Building's mechanical room.

Figure 39 – ADM-MECH-Cladding A, B and C Sample Location

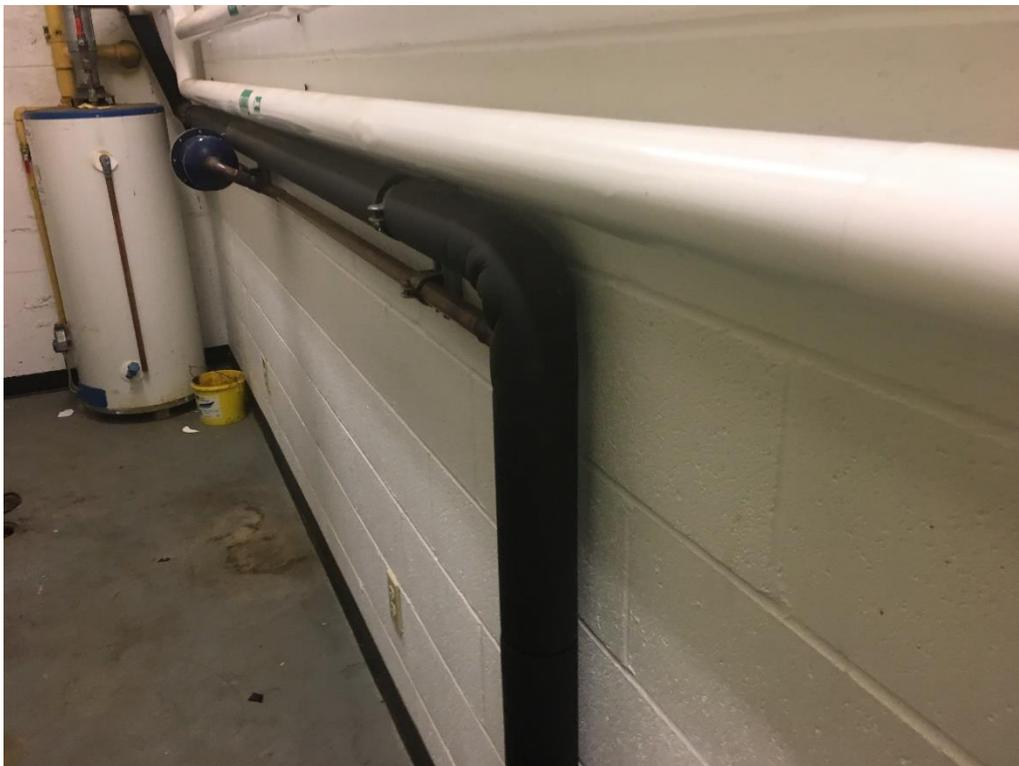
Figure 40 – Observed black foam insulation, no need to sample

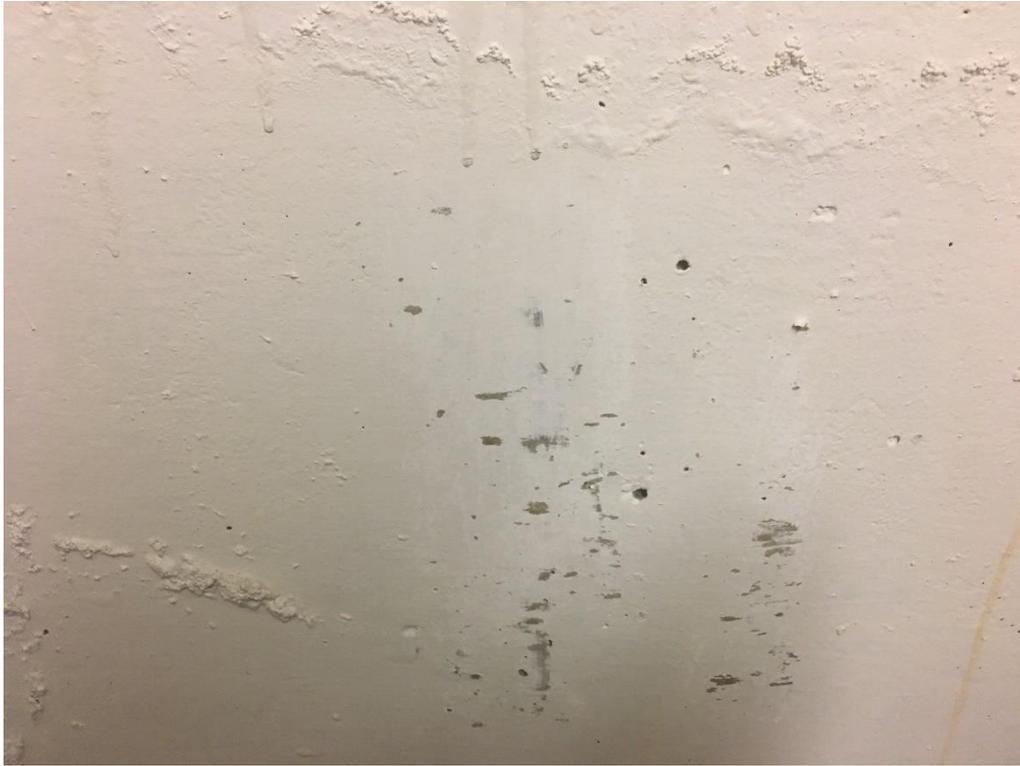
- One sample of white paint was collected for the analysis of Lead content. This paint can be found on the walls of the Administration Building's mechanical room.

Figure 41 – ADM-MECH-Paint White Sample Location

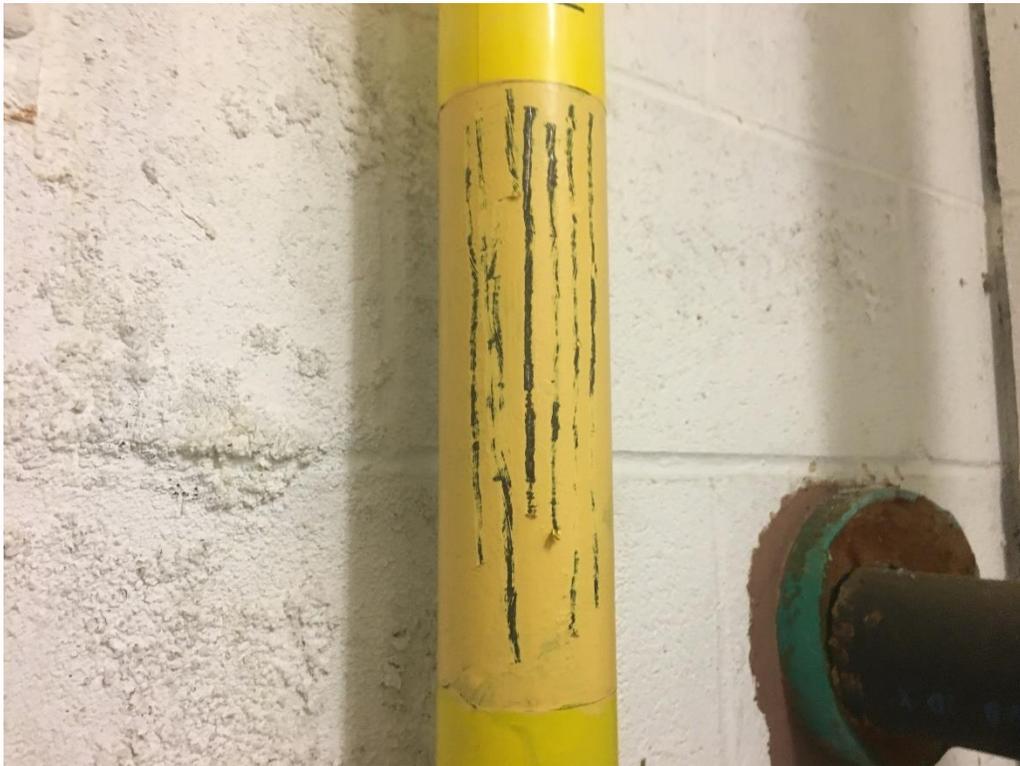
- One sample of yellow paint was collected for the analysis of Lead content. This paint can be found on a gas line located inside the Administration Building's mechanical room.

Figure 42 – ADM-MECH-Paint Yellow Sample Location

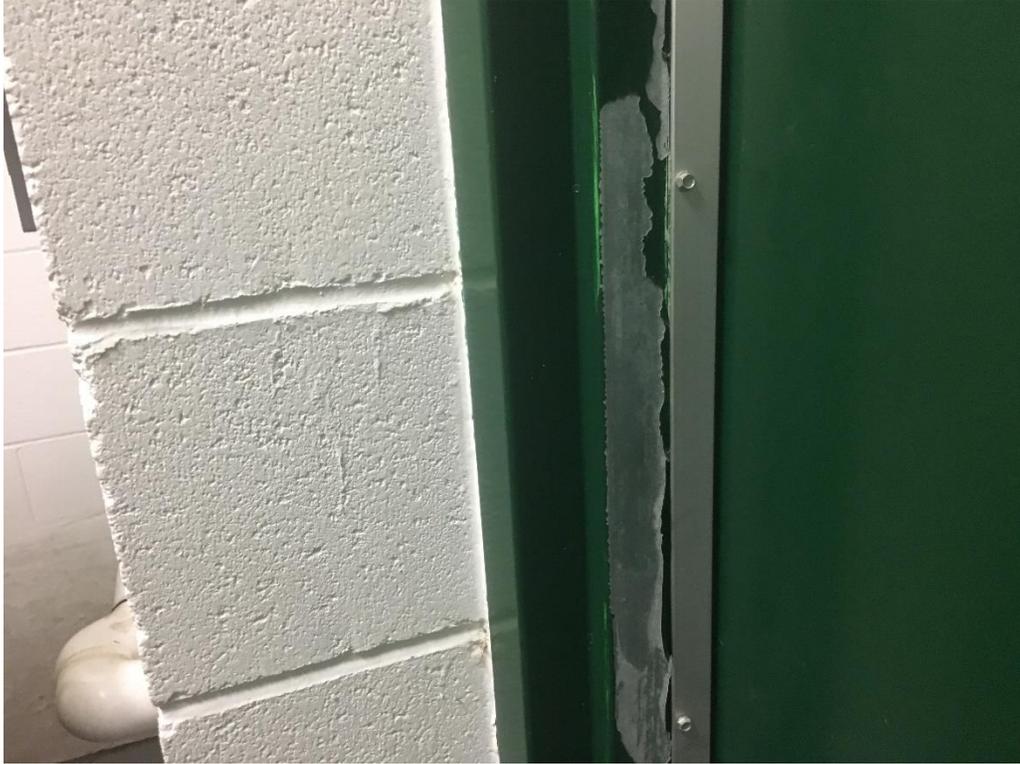
- One sample of green paint was collected for the analysis of Lead content. This paint can be found on the doors and frames of the Administration Building's storage areas.

Figure 43 – ADM-ST1-Paint Green Sample Location

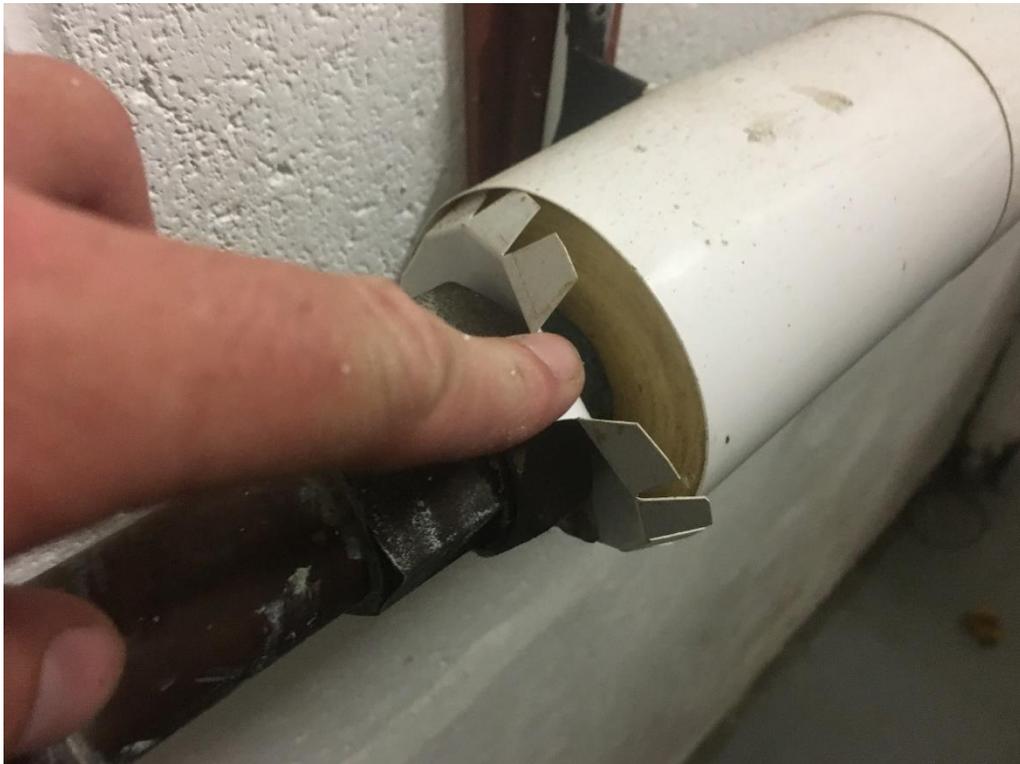
Figure 44 – Observed Fiberglass Insulation, no need to sample

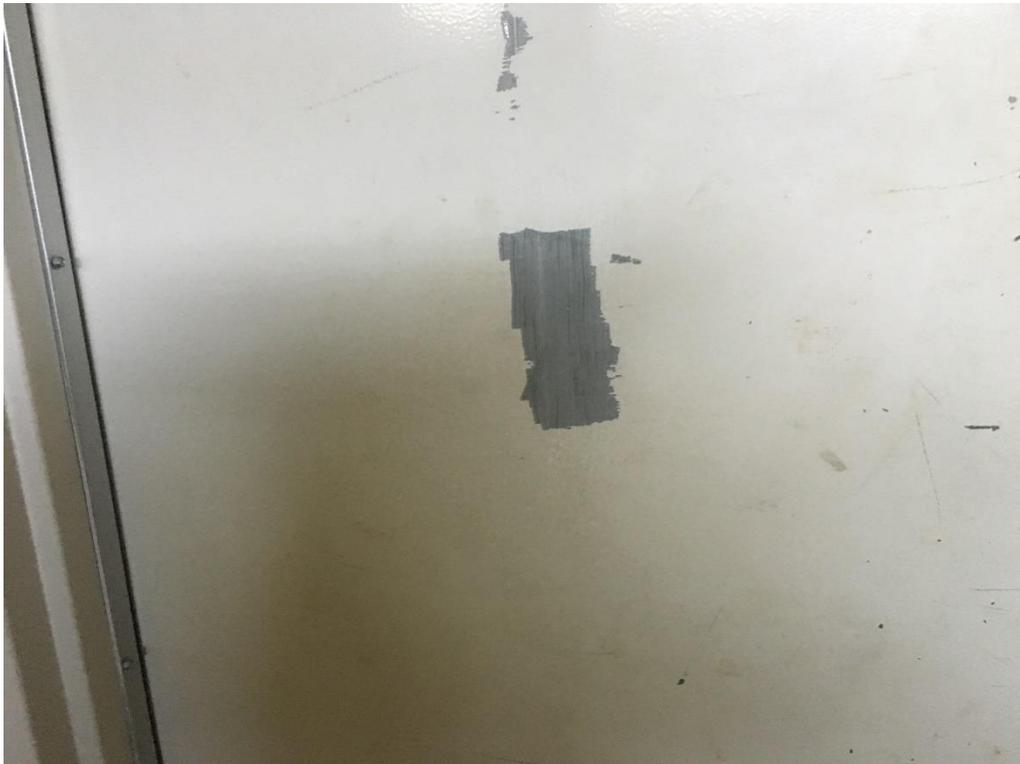
- One sample of white gloss paint was collected for the analysis of Lead content. This paint can be found on the door of the Administration Building's garage.

Figure 46 – ADM-WS-Paint White Gloss Sample Location

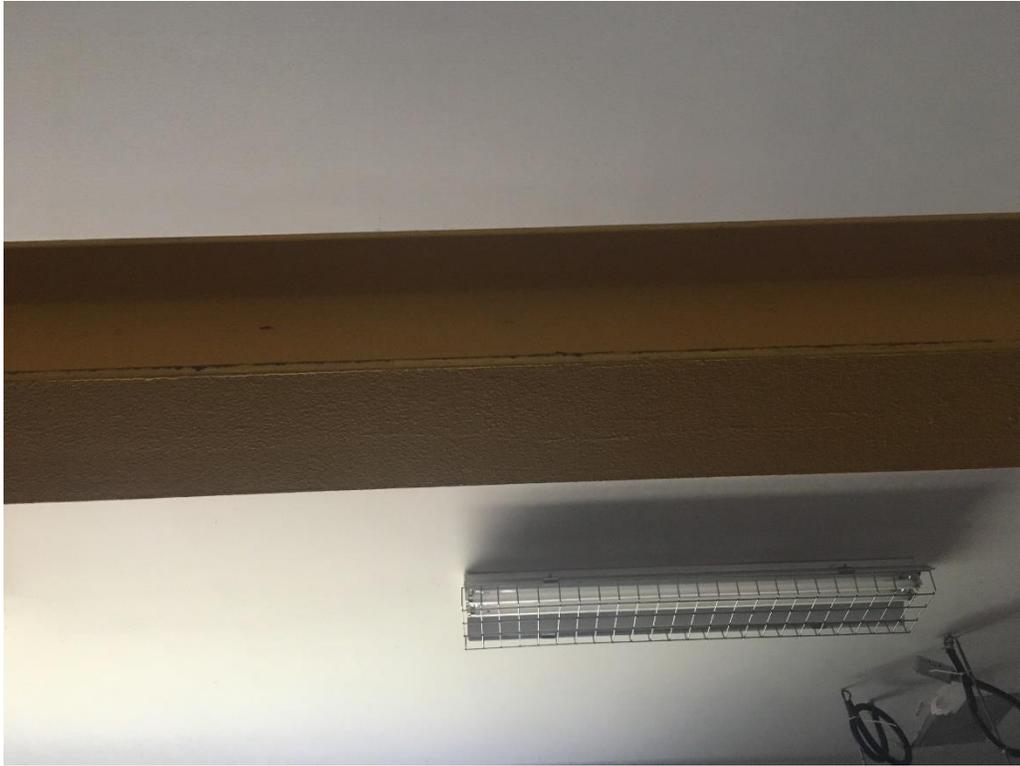
- One sample of yellow paint was collected for the analysis of Lead content. This paint can be found on the hoist beam located inside the Administration Building's garage.

Figure 47 – ADM-WS-Paint Yellow Sample Location

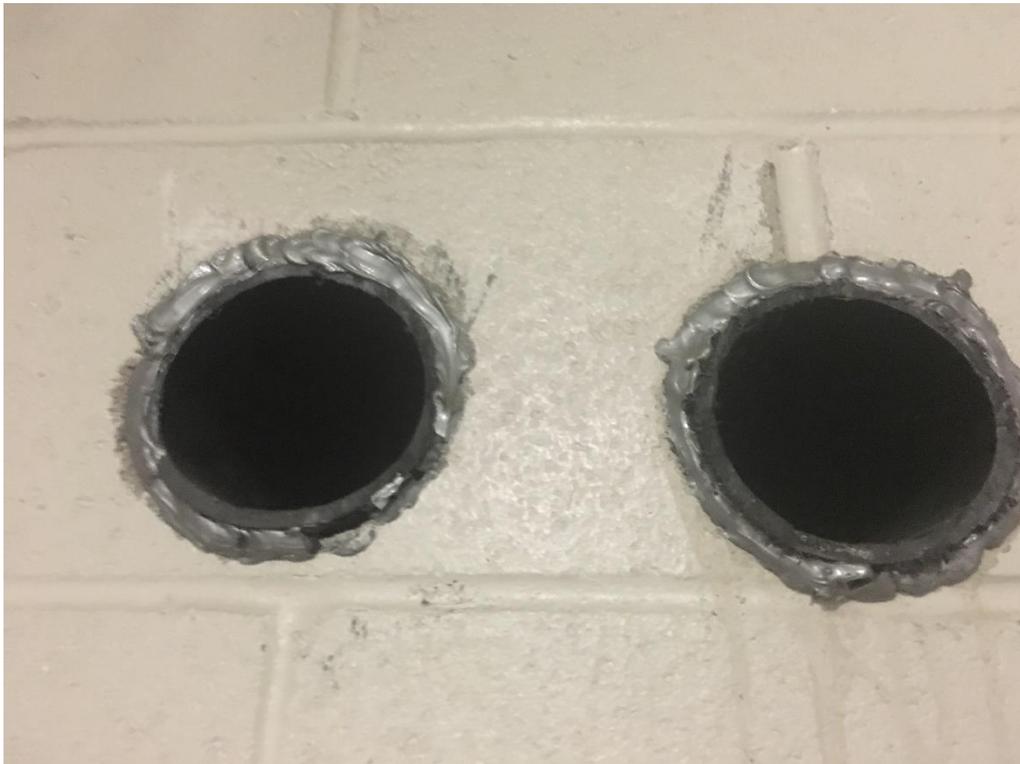
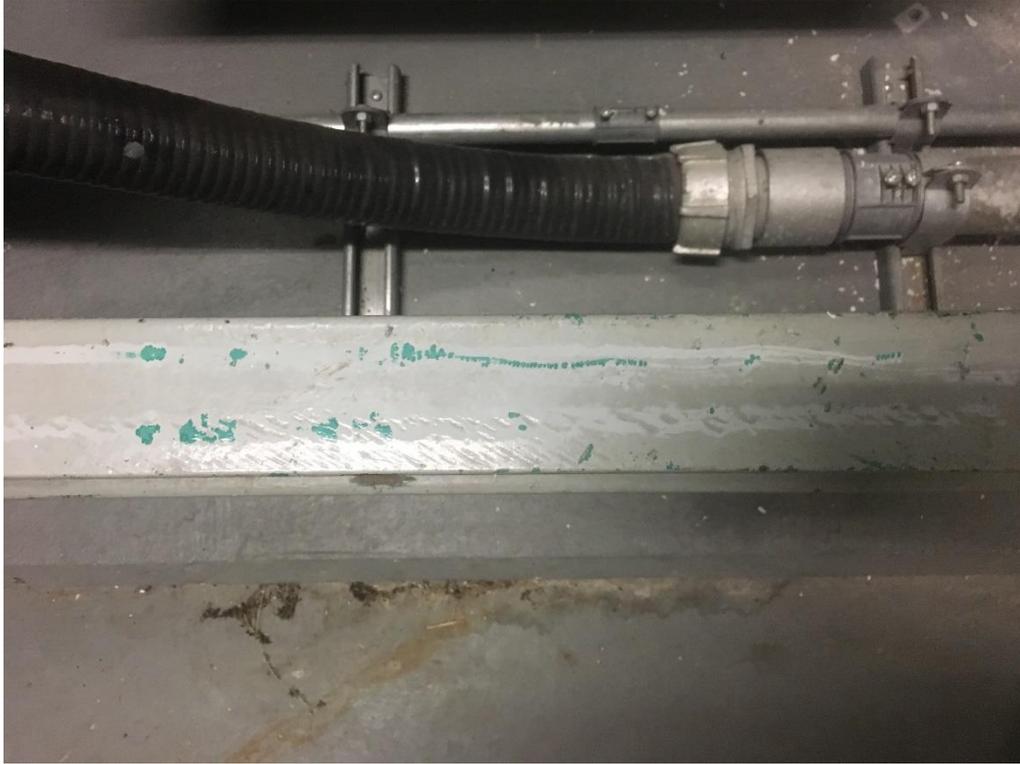
- Three samples of Caulking '1' were collected for analysis of ACM content. This caulking can be found surrounding multiple penetrations inside the Administration Building's generator room.

Figure 48 – ADM-GEN-Caulking A, B and C Sample Location

Figure 49 – ADM-GEN-Caulking A, B and C Sample Location

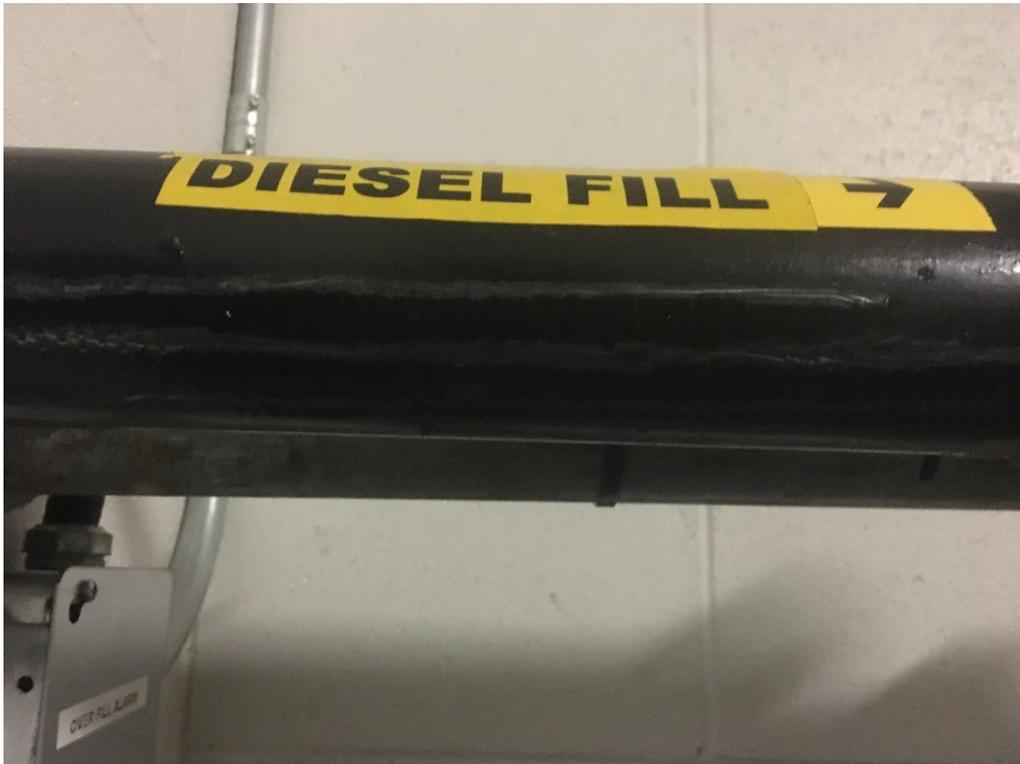
- One sample of black paint was collected for the analysis of Lead content. This paint can be found on multiple pipes located inside the Administration Building's generator room.

Figure 50 – ADM-GEN-Paint Black Sample Location

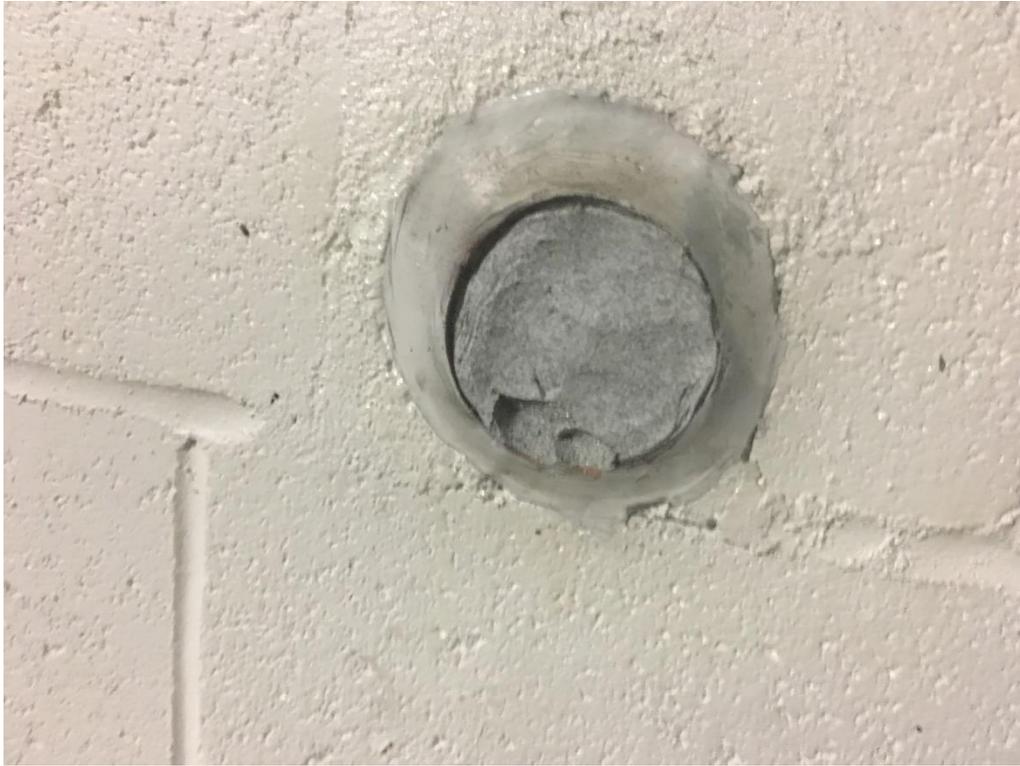
- Three samples of Caulking '2' (named "Cladding" on chain of custody") were collected for analysis of ACM content. This caulking can be found surrounding multiple penetrations inside the Administration Building's generator room.

Figure 51 – ADM-GEN-Cladding2 A, B and C Sample Location

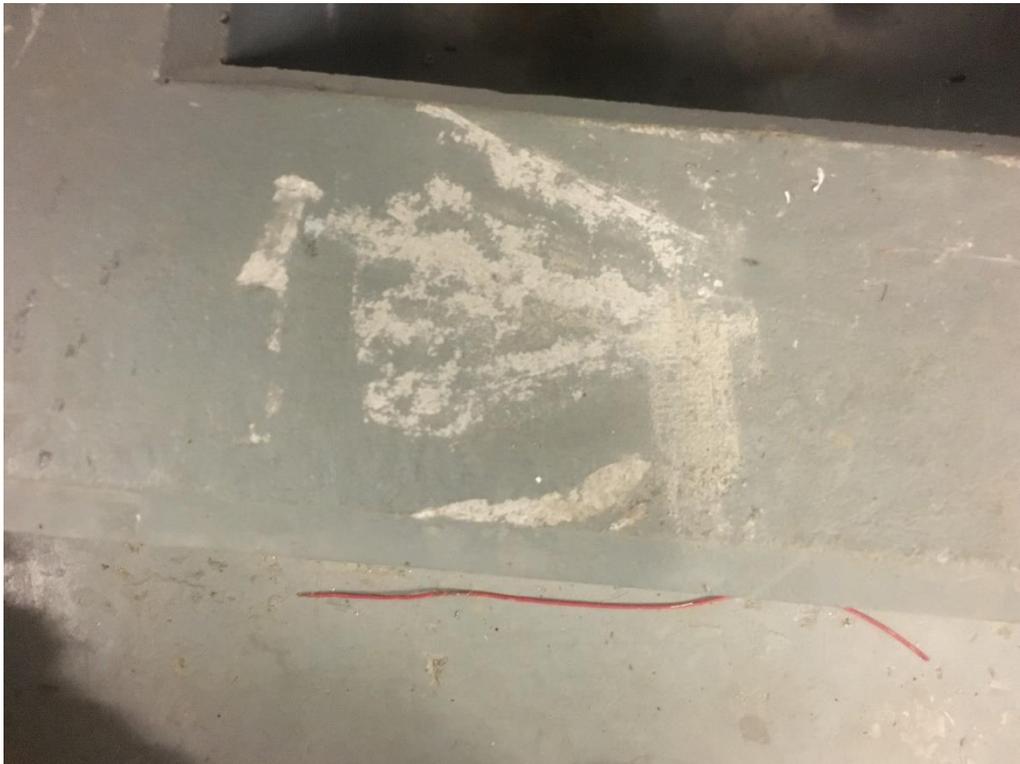
- One sample of Grey Paint '2' was collected for the analysis of Lead content. This paint can be found on floor of the Administration Building's generator room.

Figure 52 – ADM-GEN-Paint Grey2 Sample Location

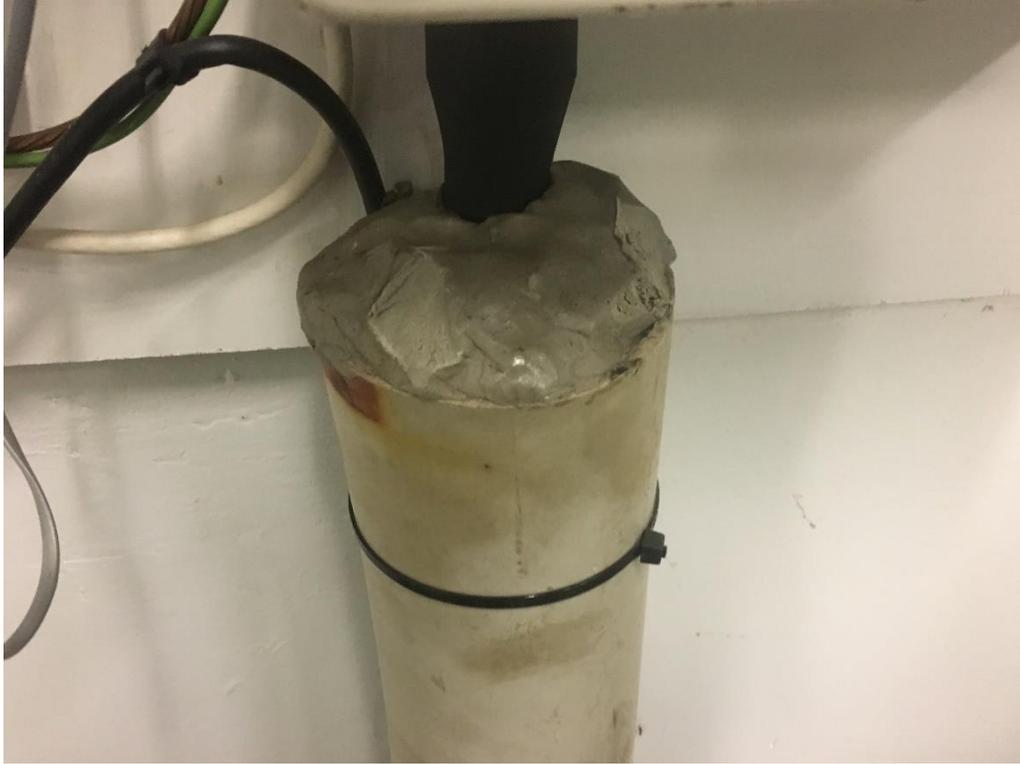
- Three samples of putty were collected for analysis of ACM content. This putty can be found surrounding multiple wires and conduits inside the Administration Building's electrical room.

Figure 53 – ADM-ELEC-Putty A, B and C Sample Location

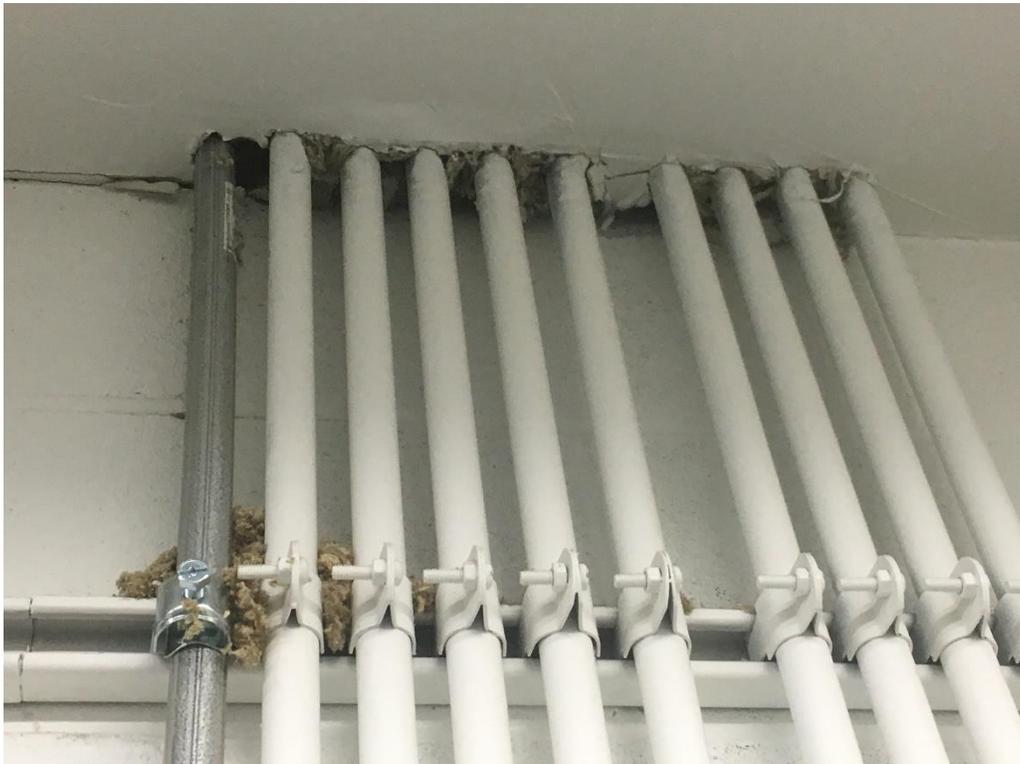
- Three samples of insulation were collected for analysis of ACM content. This insulation can be found surrounding multiple ceiling penetrations inside the Administration Building's electrical room.

Figure 54 – ADM-ELEC-INSULATION A, B and C Sample Location

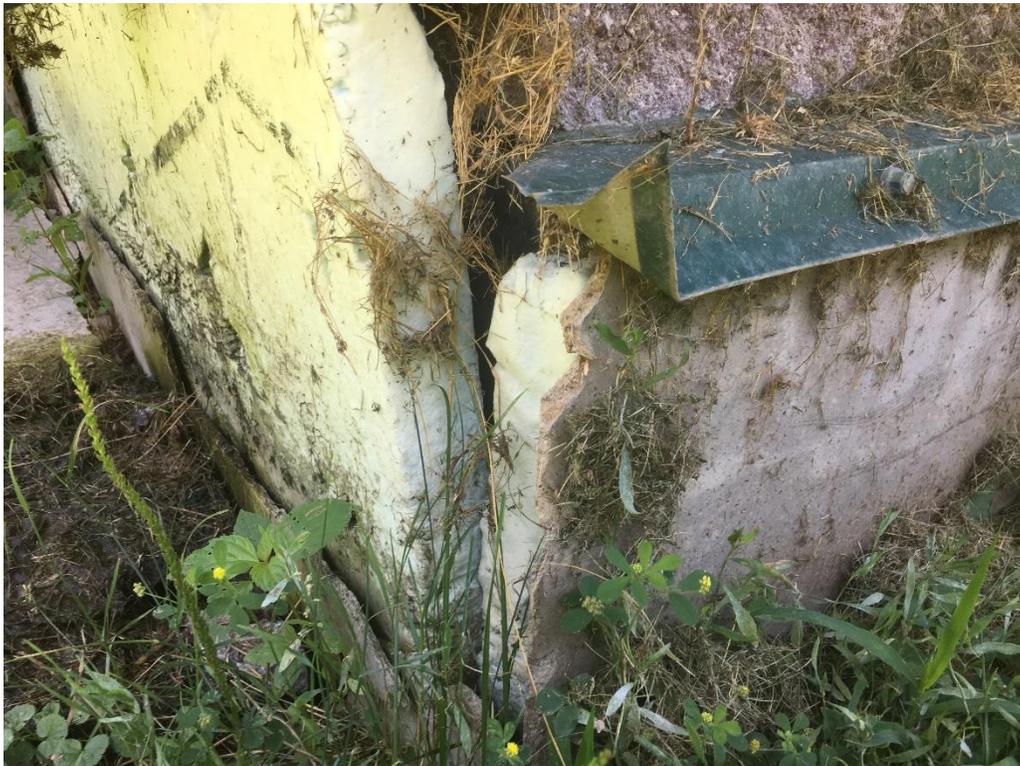
- Three samples of coated panel were collected for analysis of ACM content. This coated panel can be found surrounding the foundation of the Administration Building's exterior.

Figure 56 – ADM-EXT-Coated Panel A, B and C Sample Location

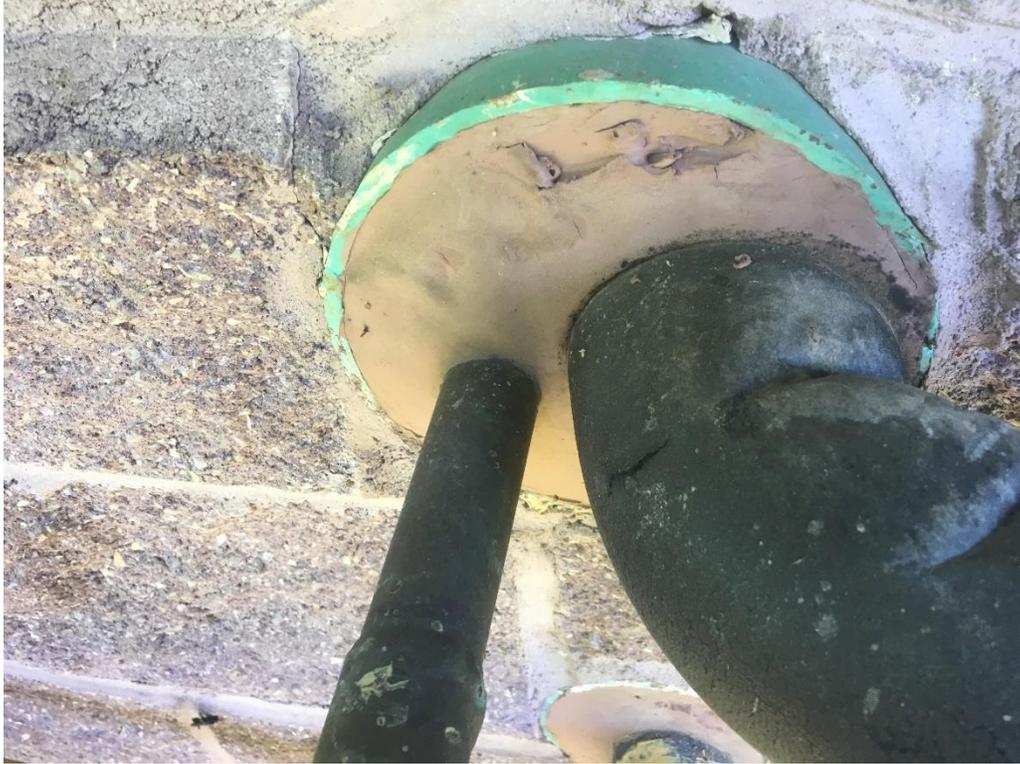
- Three samples of firestop were collected for analysis of ACM content. This firestop can be found surrounding multiple penetrations on the south side of the Administration Building's exterior.

Figure 57 – ADM-EXT-Firestop A, B and C Sample Location

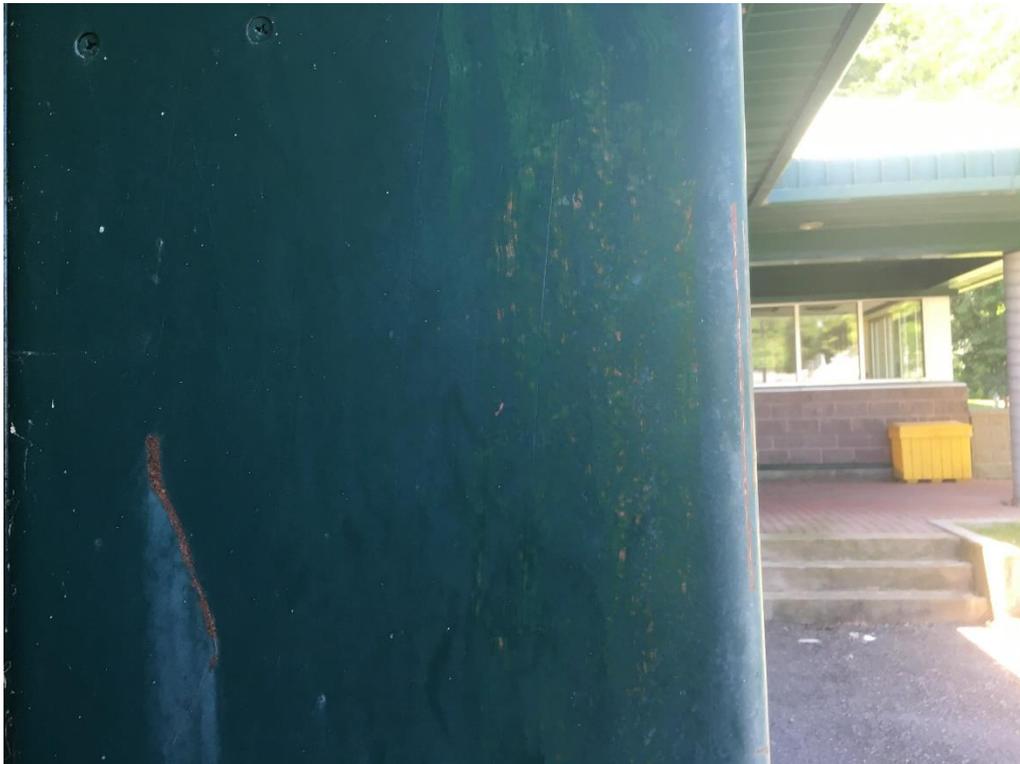
- One sample of green paint was collected for the analysis of Lead content. This paint can be found on exterior flashing of the Administration Building.

Figure 58 – ADM-EXT-Paint Green Sample Location
