Township of South Stormont

Ingleside WWTP, 14754 County Road 2, Ingleside

Full Site DSR

Project #: 9987
Date: August 2019

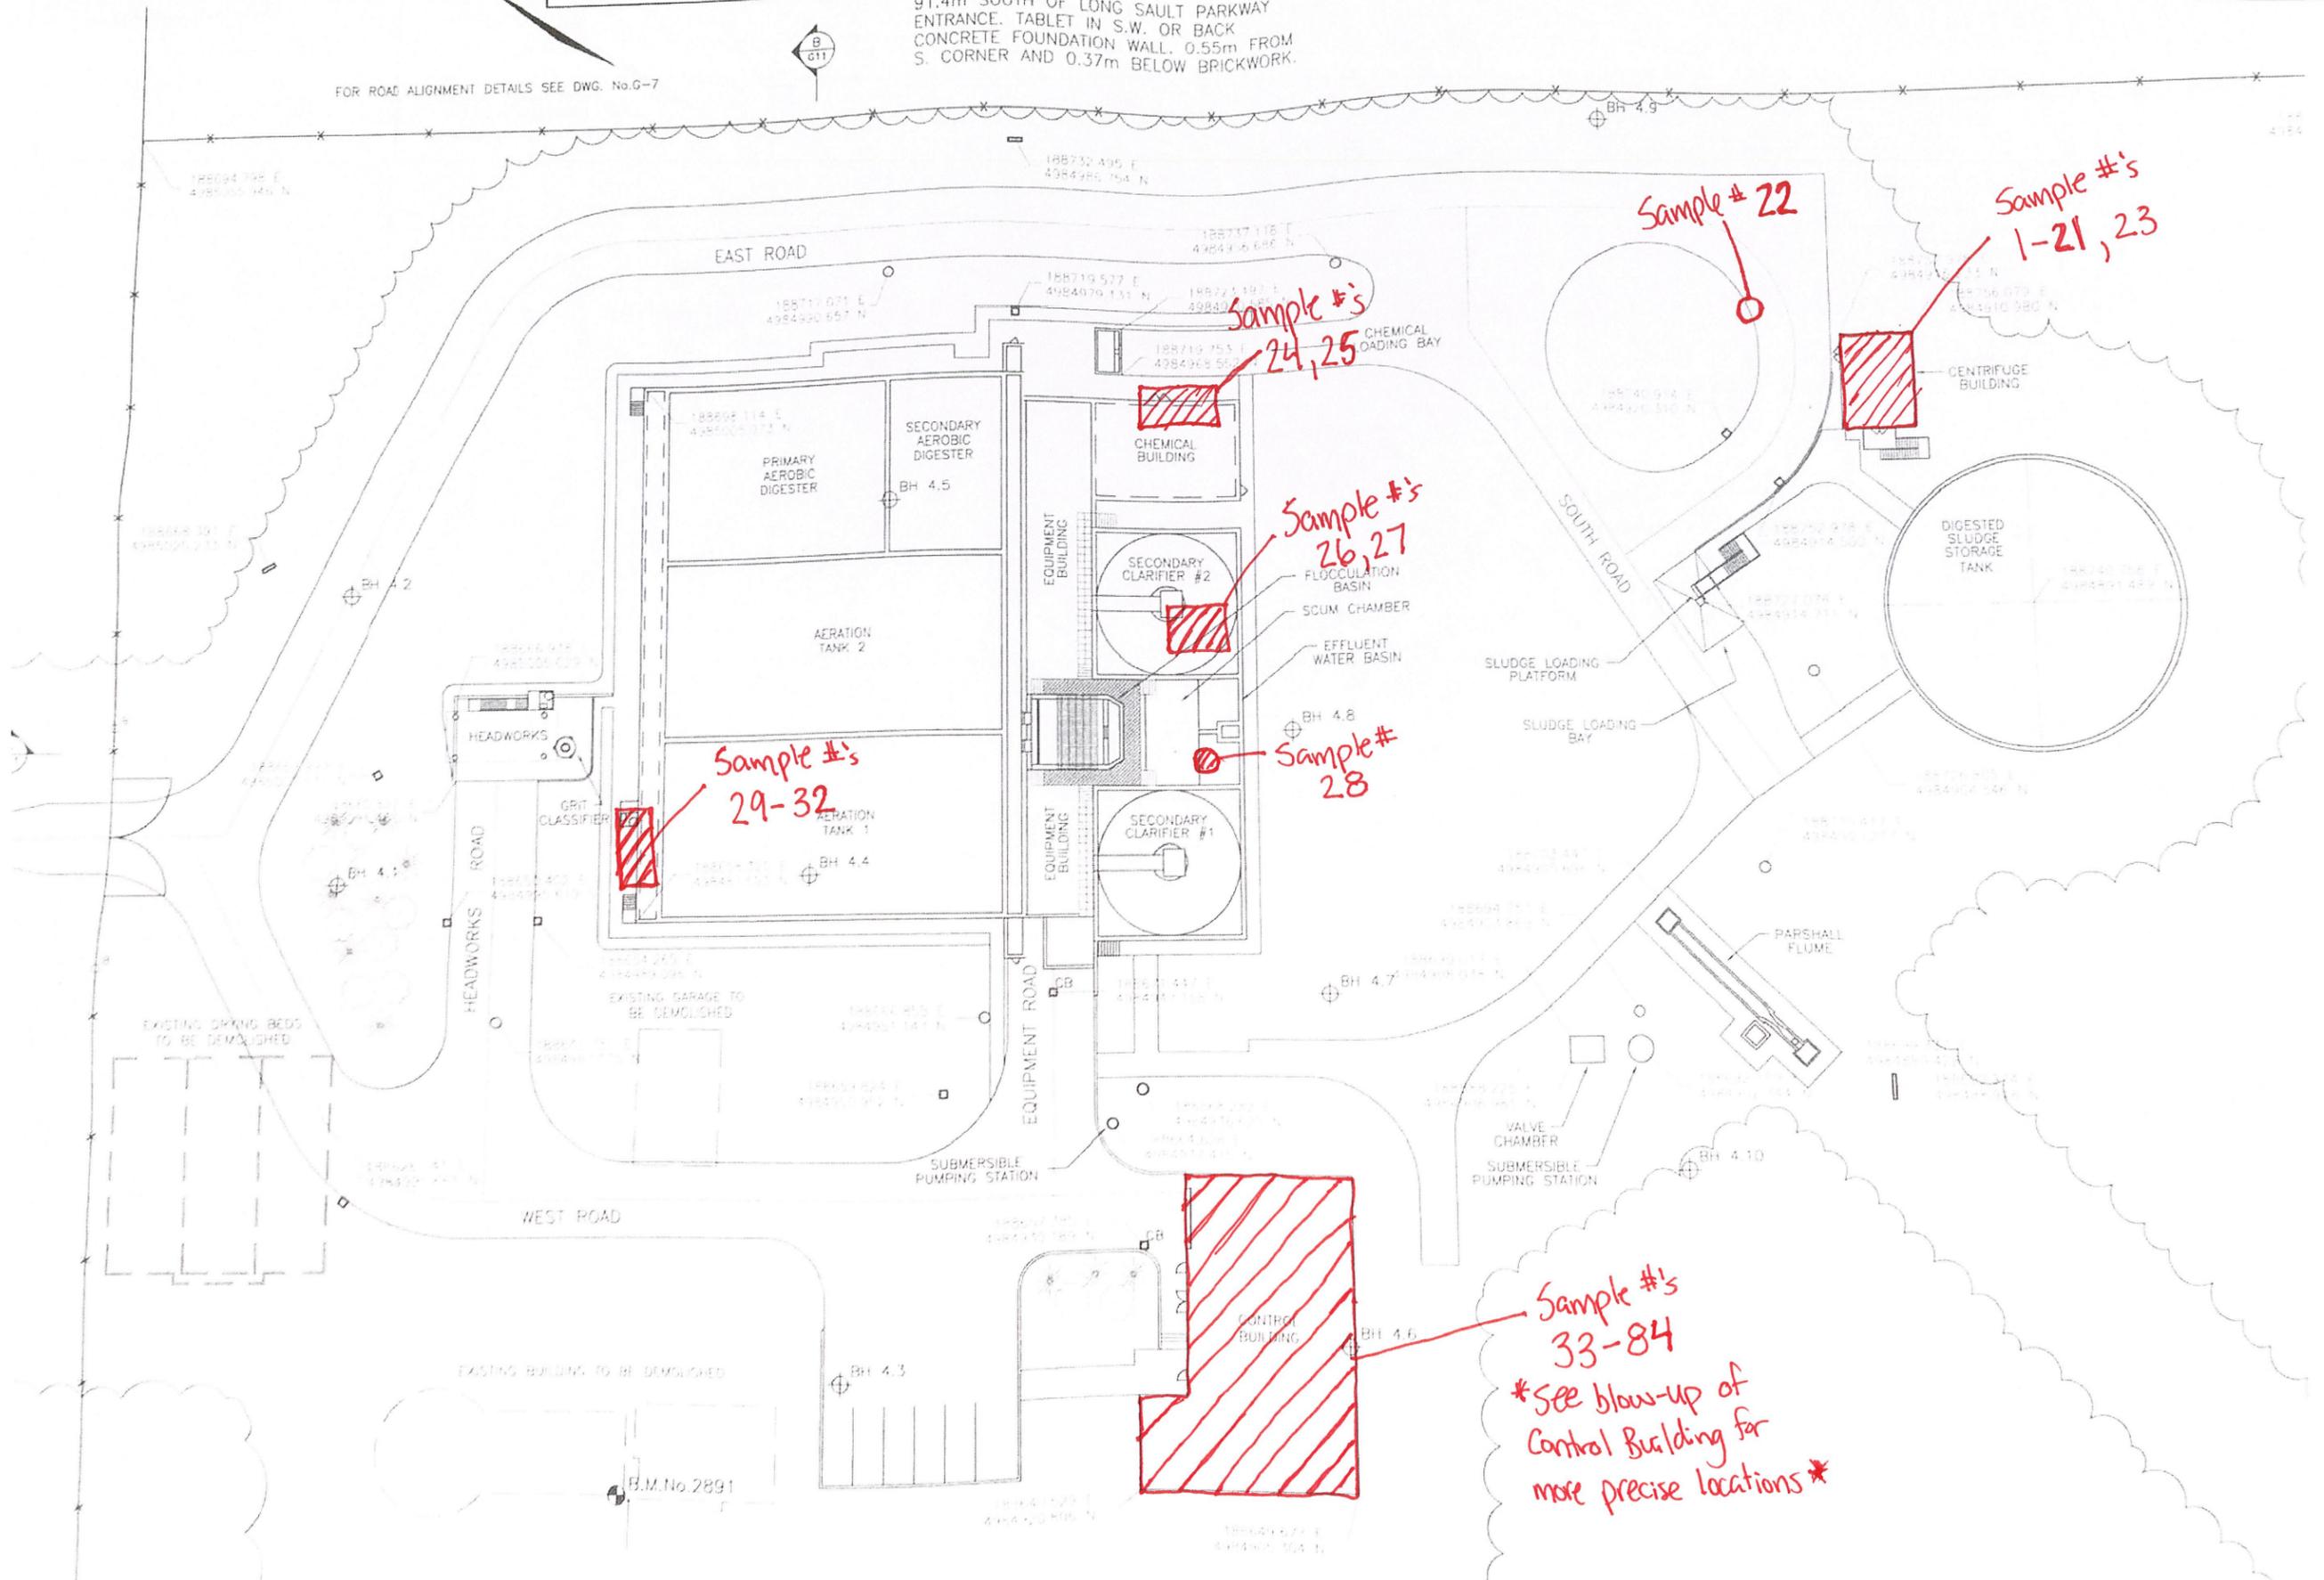
DWG#
02

Sample #'s
33-84
*See blow-up of
Control Building for
more precise locations*
